Gammel Strand, KBM3828

Cultural Historical Report, Metro Cityring Excavation

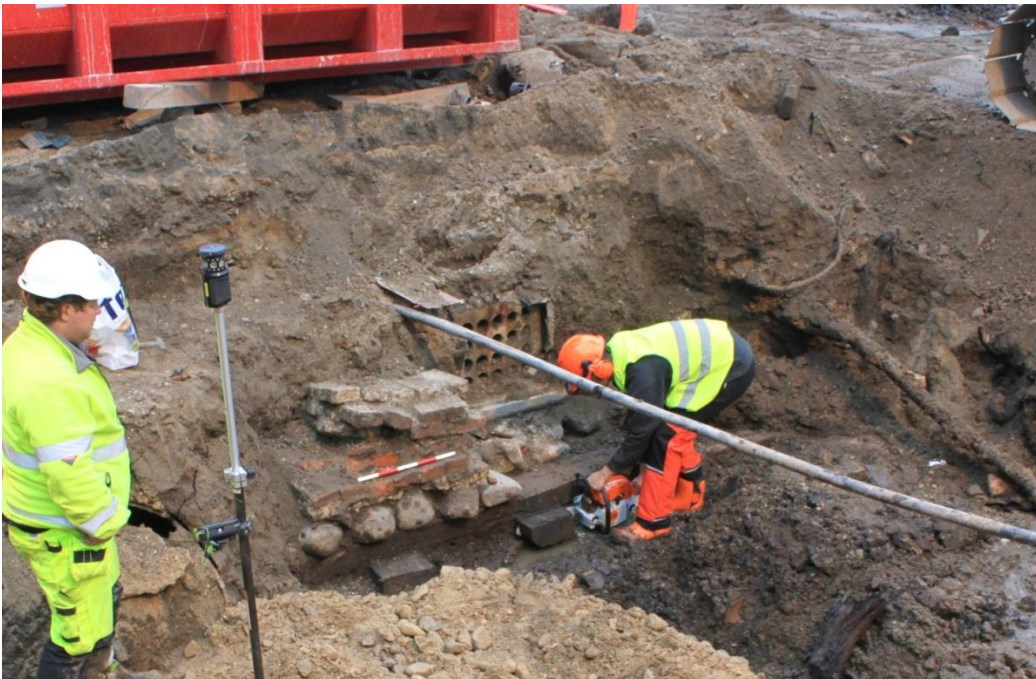
Fig. 7 Working photo of the Oil Container trench and the sawing of wood for a dendrochronological sample. C19-20121123_4354.

The trench was excavated briefly at the end of areas 1-4 in the Guide Wall excavation in October 2012. The 29.38 m² trench was excavated in watching brief conditions, which became a mini excavation after structures and features were found. The highlights of the trench comprise the unearthing of the foundations of the Renaissance harbour wall, bulwark posts and later Vragerbros building foundations.

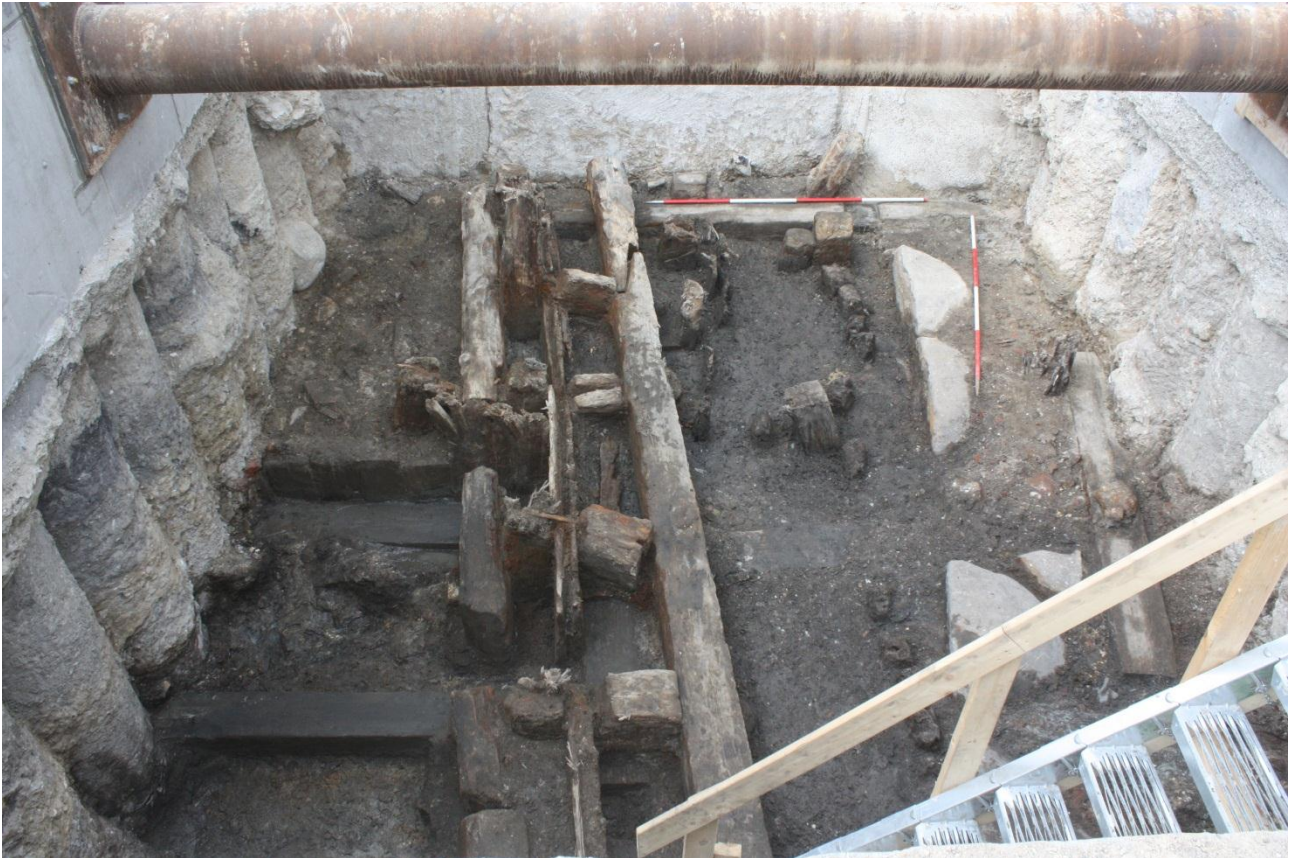
Fig. 10 Stairway trench looking west C02_20140508_9260

This trench was excavated in 2014 at the same time as the Main Excavation trench. The trench, measuring 35.25 m², was not covered, so experienced periods of heavy rain, and with flooding, was unworkable for small periods of time. It was excavated in full excavation style and used a winch system to remove big bags.

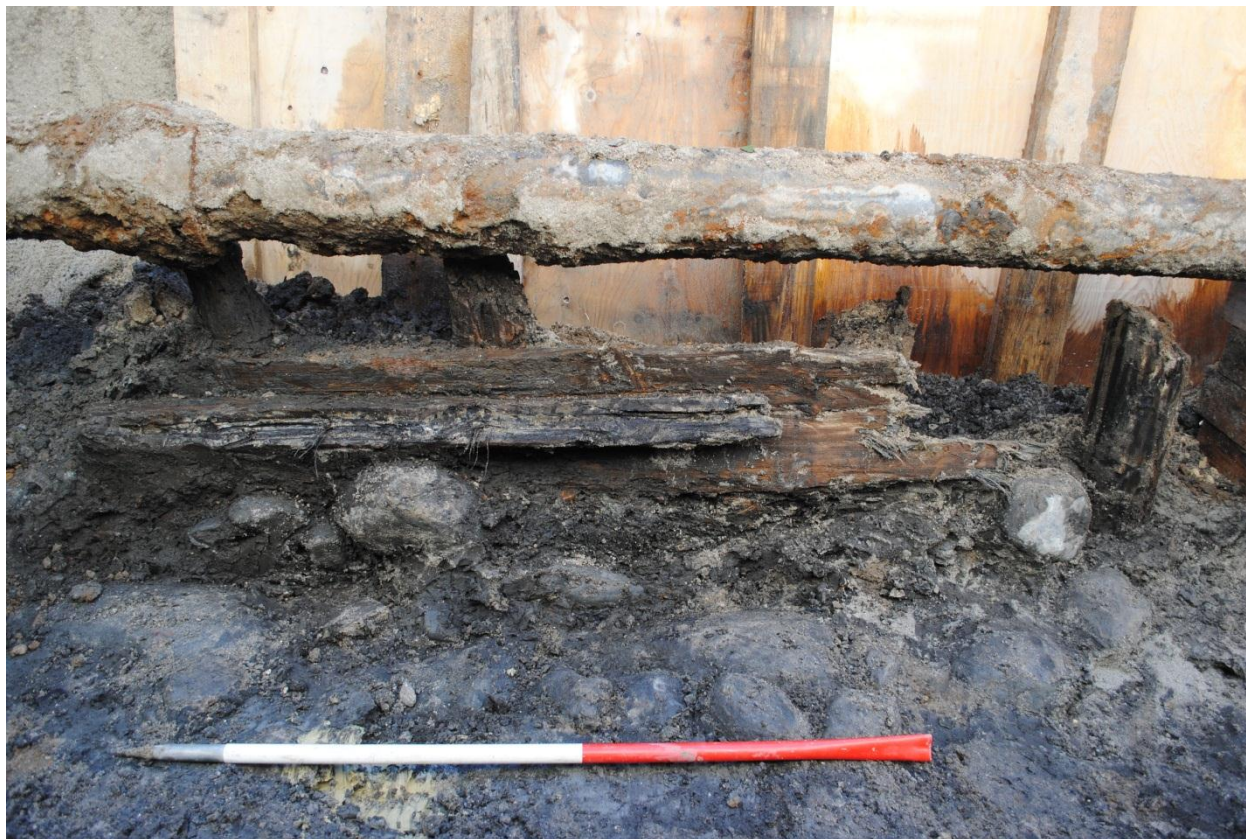
Fig. 16 A section of bulwark group SG256 looking south. Note the vertical posts, horizontal planks and variety of stone at front of photo. C07_20101026_0455

The harbourfront in the central area consisted of a horizontal wooden façade of planks, set behind vertical posts. Behind the wooden façade were large stones, either as packing, top of the stone harbourfront or road on the stone harbourfront. A line of posts were then located south of this area, suggesting a line of storm posts. To the east of this structure was located an extension of this harbour, or perhaps a new harbour. The 1400s harbour was spread over an area measuring 59.5 m. It was backfilled to the north with Late Medieval waterlogged soils, which then built up south of the harbourfront at the harbour base. Within these soils were late residual High Medieval sherds from earlier rubbish dumps from the city and Late Medieval finds from use of the harbourfront. Finds that represent this harbourfront comprise pottery such as Siegburg ware, grey ware and some local Copenhagen redwares, glass from Bohemia, leather shoes and a rare galloche, fastenings from clothing and diet represented by animal bones and fish bones.

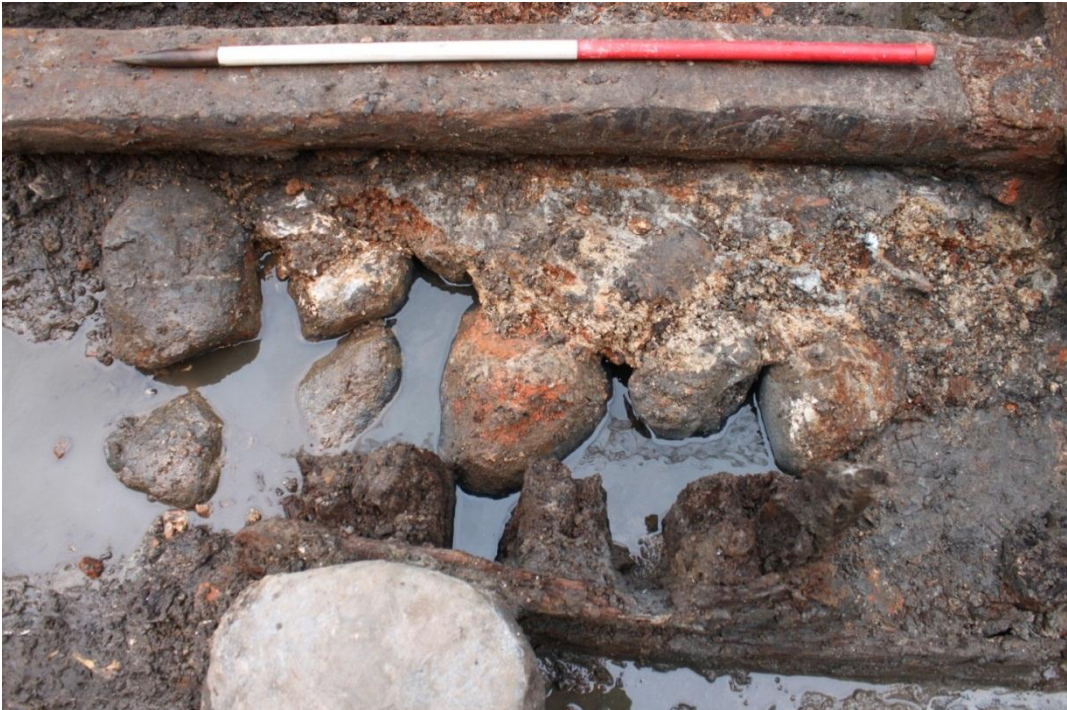
Fig. 20 Bulwark Group 467 in foreground. Stone harbour wall 532 from Phase 2 in centre, with Phase 4 land tie at the top of the photo. Photo facing south east. C19_20120924_3933

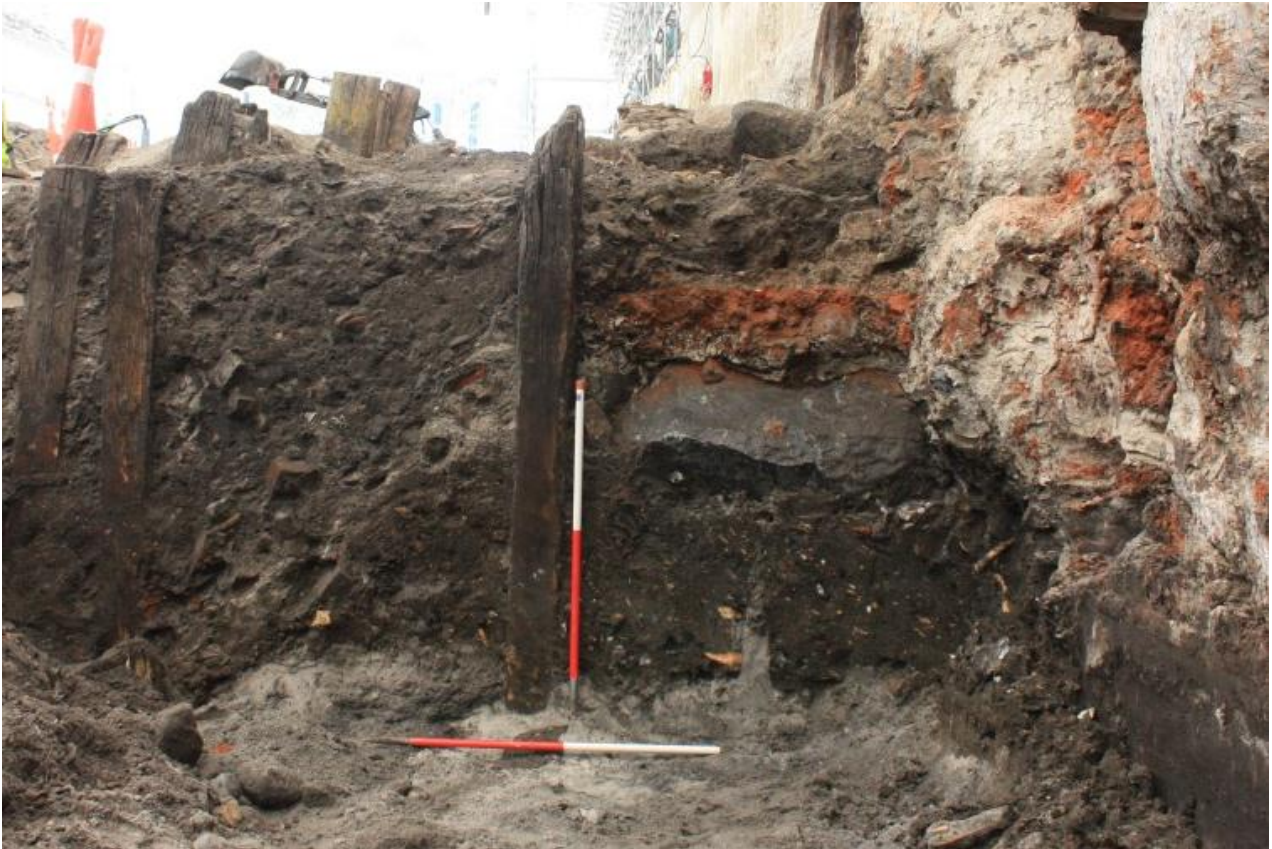
Fig. 21 Section containing SD40492 at the base and THE bottom right of photo. Facing NE. C02_20140624_10044 (cropped)

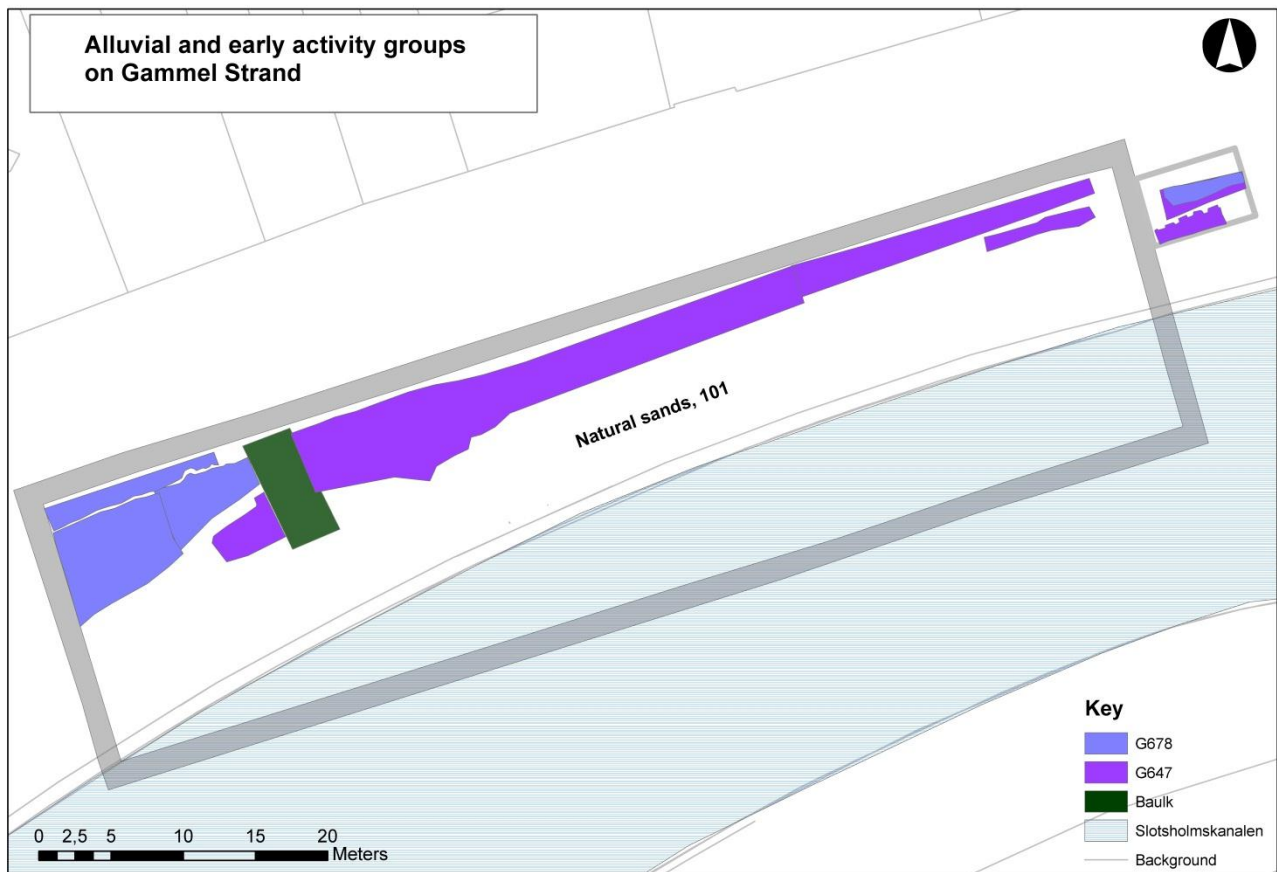
Fig. 23 Plan of G647 & G648. Alluvial and activity layers in Phase 1

The area comprising groups G647 and G678 measured 84.41 m long (east-west) by (north-south) 6.11 m wide in the centre and 8.41 m at the western end of the Main Excavation trench. The deposits in the groups were generally thicker at the northern end of the site, reducing in size as they continued southwards. Groups 647 were mainly located in the central and eastern areas of the main trench and partly in the western area and stairway trench. Group 678 was found in the stairway trench and in the far western end

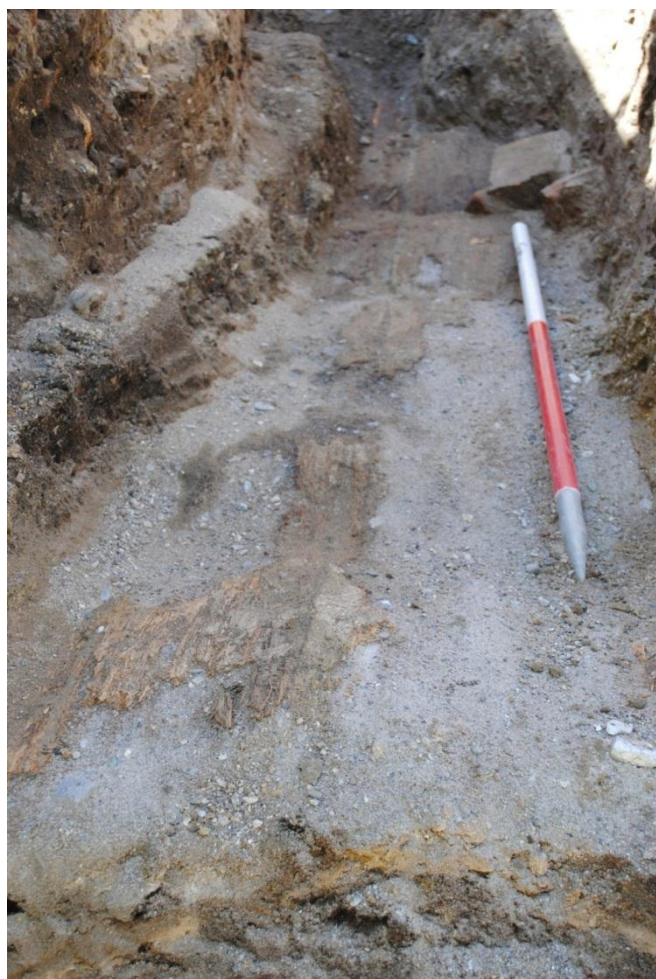
Fig. 26 Floor G233 within building G389. Looking NW.
C07_20100628_0173

The possible *Vejerhus* comprised a few layers of wooden floor, perhaps constantly refurbished due to flooding of the soil below from the tides. It comprised sturdy walls with a basement consisting of a barrel re-used for drainage and an earthen base that was kept relatively clean until its demolishing. The foundations were set with a construction cut consisting of a large stone base with an overlying brick wall. The purpose of the building was to weigh and then tax the goods from the harbour, an essential cog in the trade system. They were located in every major harbour town, sometimes incorporating a custom house or separate from them.

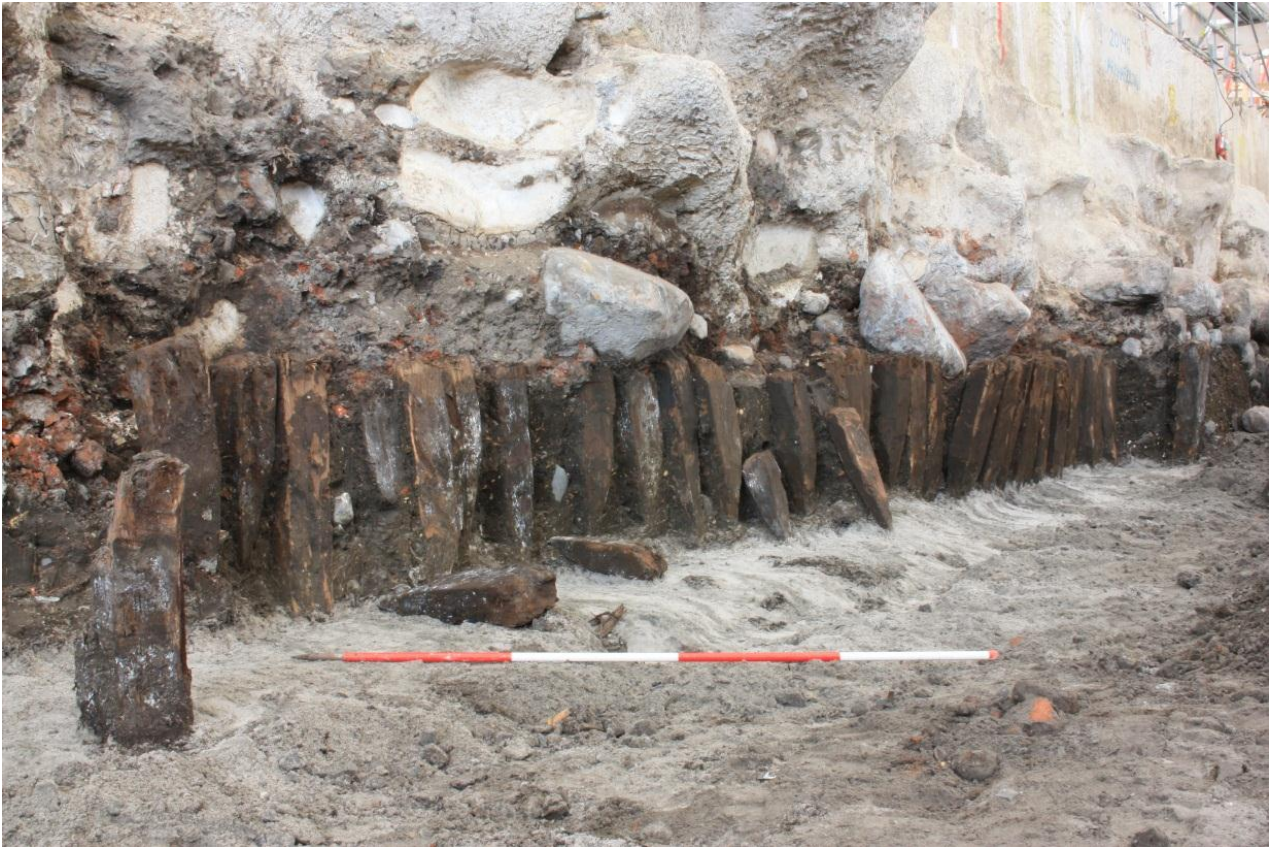
Fig. 29 Oak posts from a Late Medieval bulwark in the Main Excavation, central area. Part of Group 656. Note the truncated top of the posts with the c. 1580s stone harbour above, concreted into the Guide Wall. Photo looking NE. C02_20140623_10013

The 1530s harbour comprised posts set over an area 76 metres long, and was uncovered only in the Main Excavation trench. These posts were pushed into Late Medieval alluvial deposits which lay at the base of the harbour. They were mainly oak, probably from *Skåne*, *Sjælland* or *Halland*, cut into a rectangular shape with one pointed end and one flat end. The majority of these posts were approximately 2m long and 0.3m long, pushed into the ground, vertically. Their date range was quite broad from the 1490s to the 1530s and it is probable that some were re-used from the early 1500s harbour.

The majority of the posts were found measuring only 1m long, with one end truncated and one end sharpened. This was due to truncation at the end of Phase 1 where the harbour changes in style and

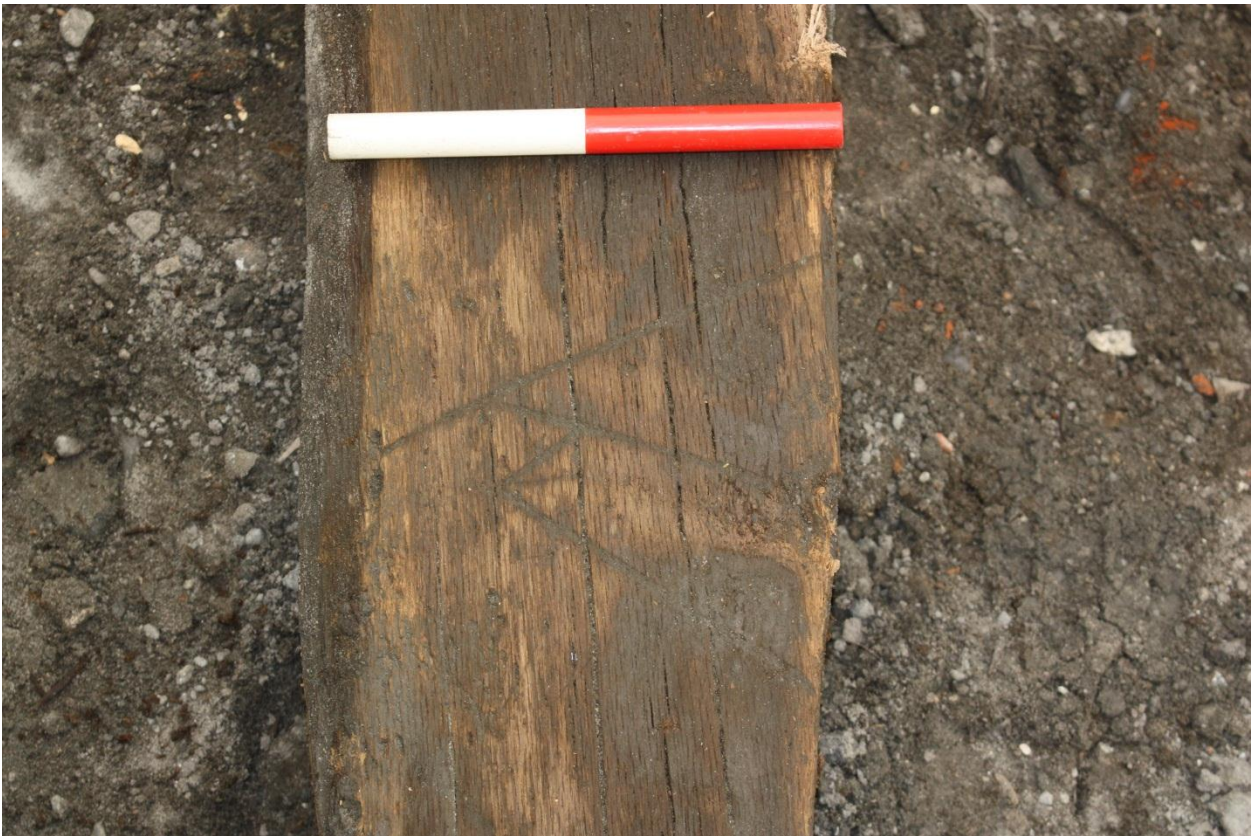
Fig. 30 Working photo showing post ST544550 with carpenters mark. C02_20140612_9723

material. These posts appear to have been re-used in another role as part of foundations for harbour wall G532 after the Phase 1 harbour went out of use, whilst some were pushed in at angles and some were simple discarded as seen by post holes.

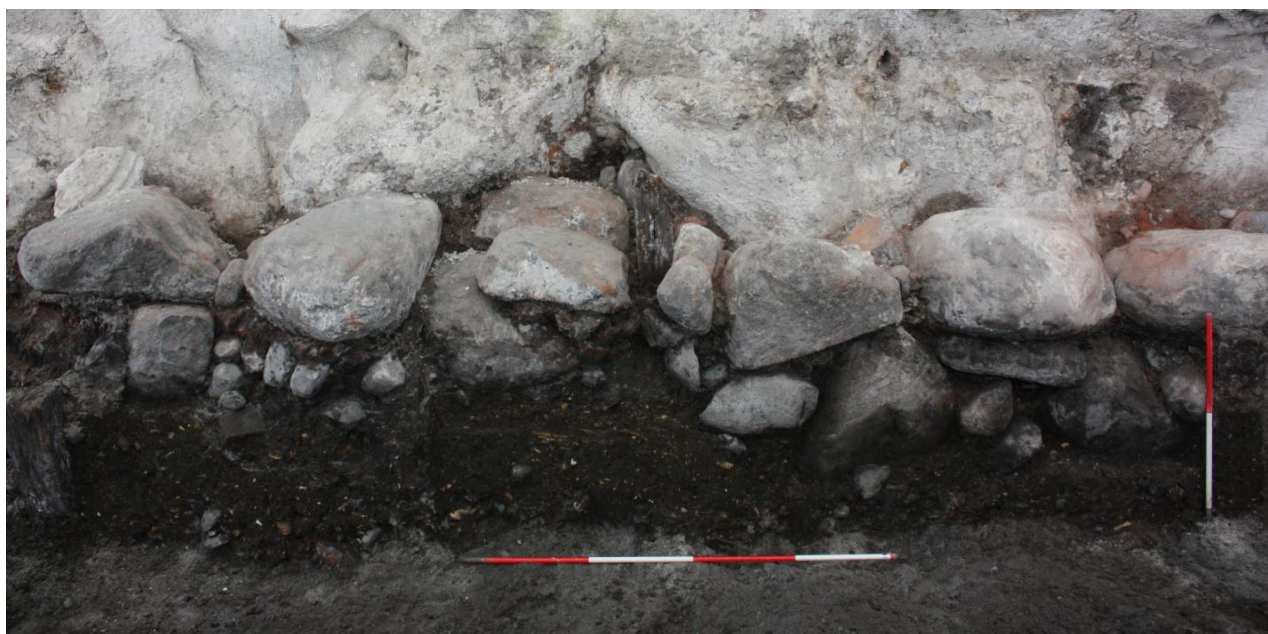
Fig. 34 Deposit SD42912 of sub-group SG667, central area of Main Excavation. The deposit overlies SD37646 of Group G647, a less organic and more sand rich deposit. C03_20140623_11124

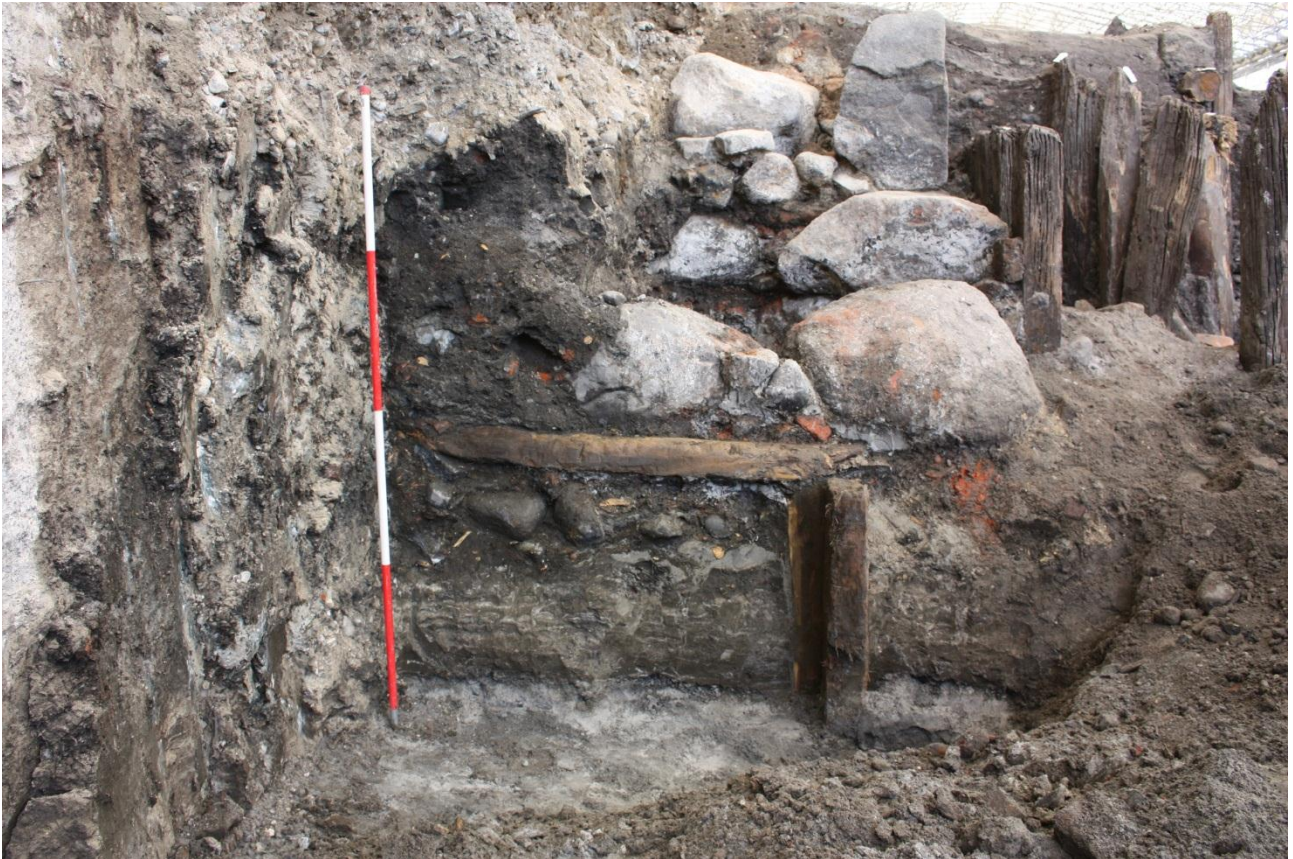
Fig. 39 Photo showing the west facing section of wall G532. Note that the rear of the wall has been truncated, as had the top of the wall by later activity. The Late Medieval harbour bulwark G656 has been cut or snapped with the upper part of the post horizontally placed on a north-south orientation C03_20140630_11307

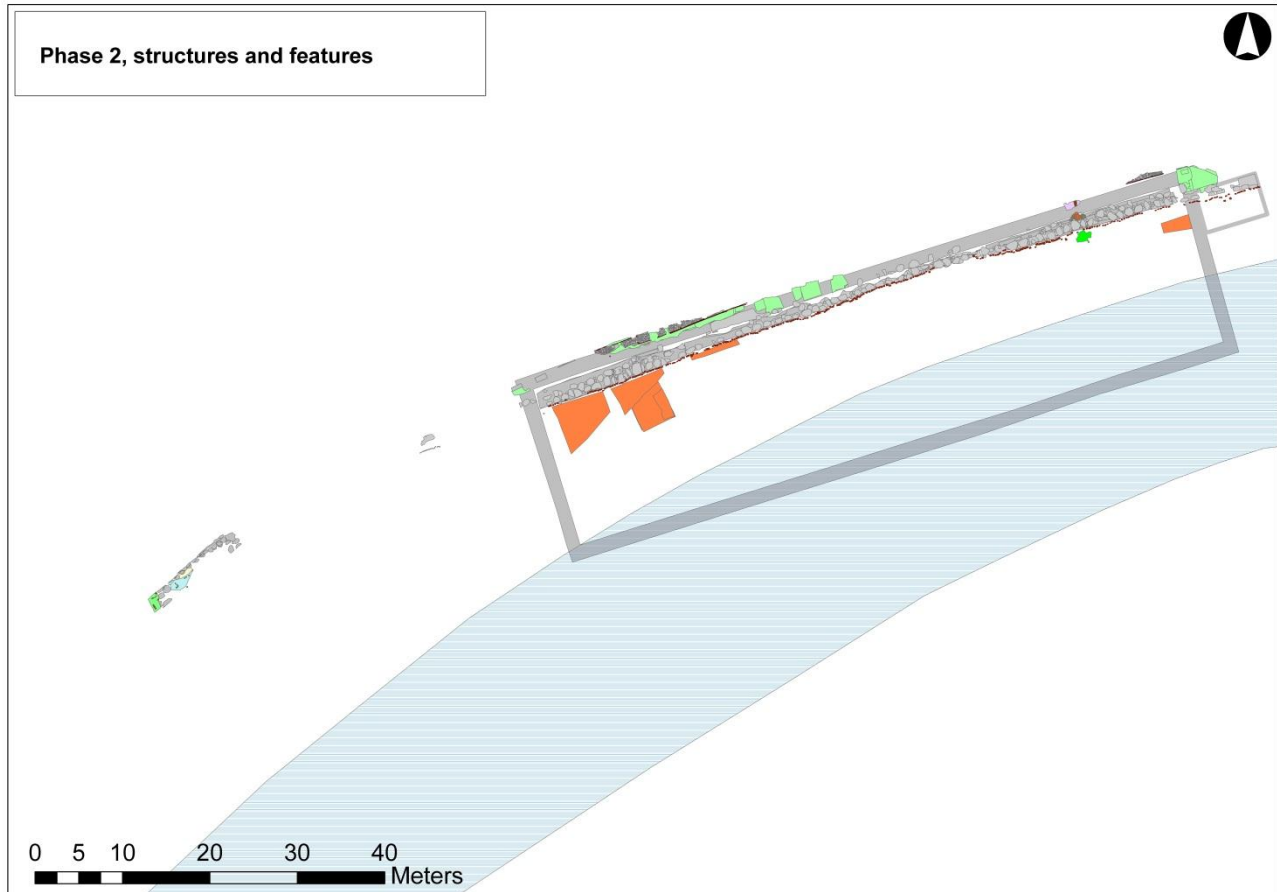
Fig. 41 Plan of Phase 2 structures and features

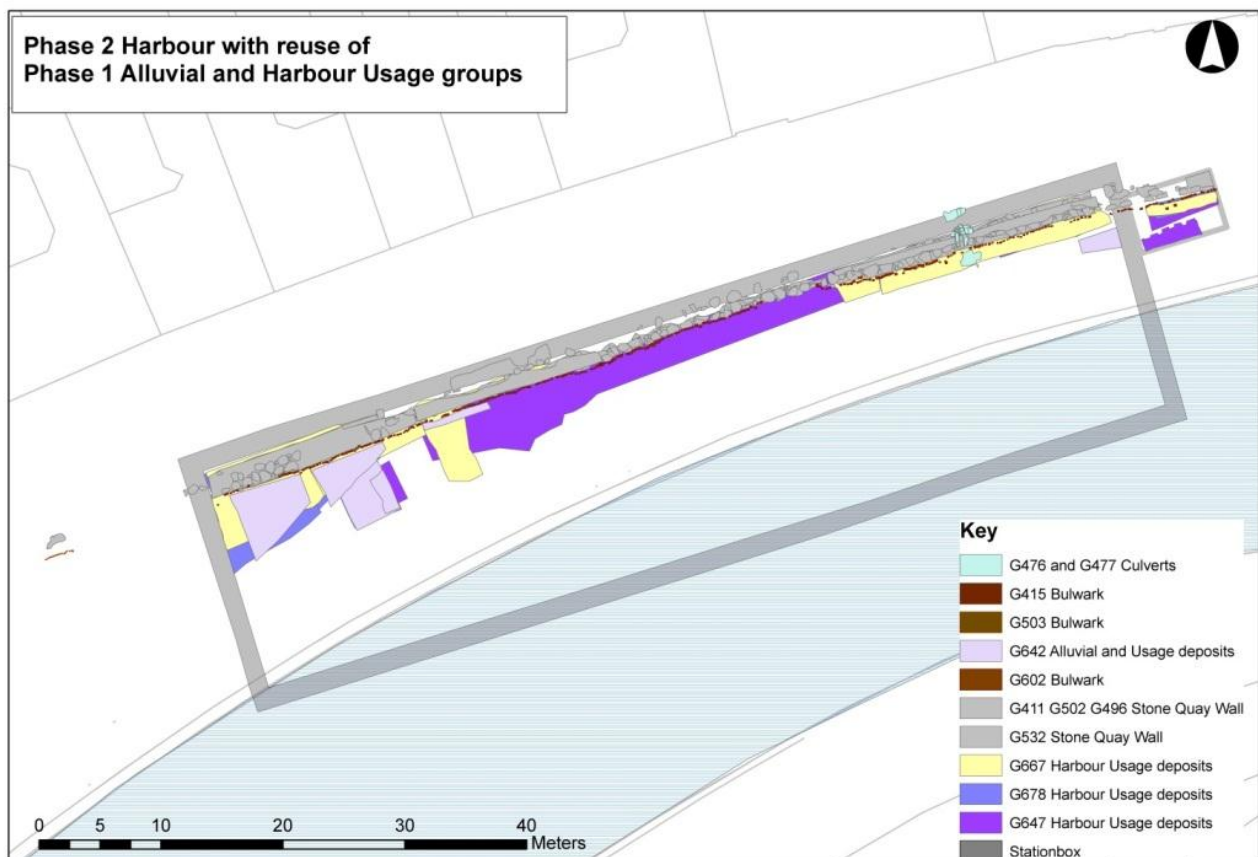
Fig. 43 Plan of harbour wall G532, Bulwarks G602, G503 and G415 and the harbour deposits, featuring the re-use of Phase 1 groups G647, G678 and Phase 2 alluvial group G642.

Associated with the harbour wall were various wooden bulwarks, set either in-front or south of the wall G532. The post line was found to continue outside of the Main Excavation trench and the stairway trench, and was represented by G415 in the Guide Wall excavation and G503 in the Oil Container trench.

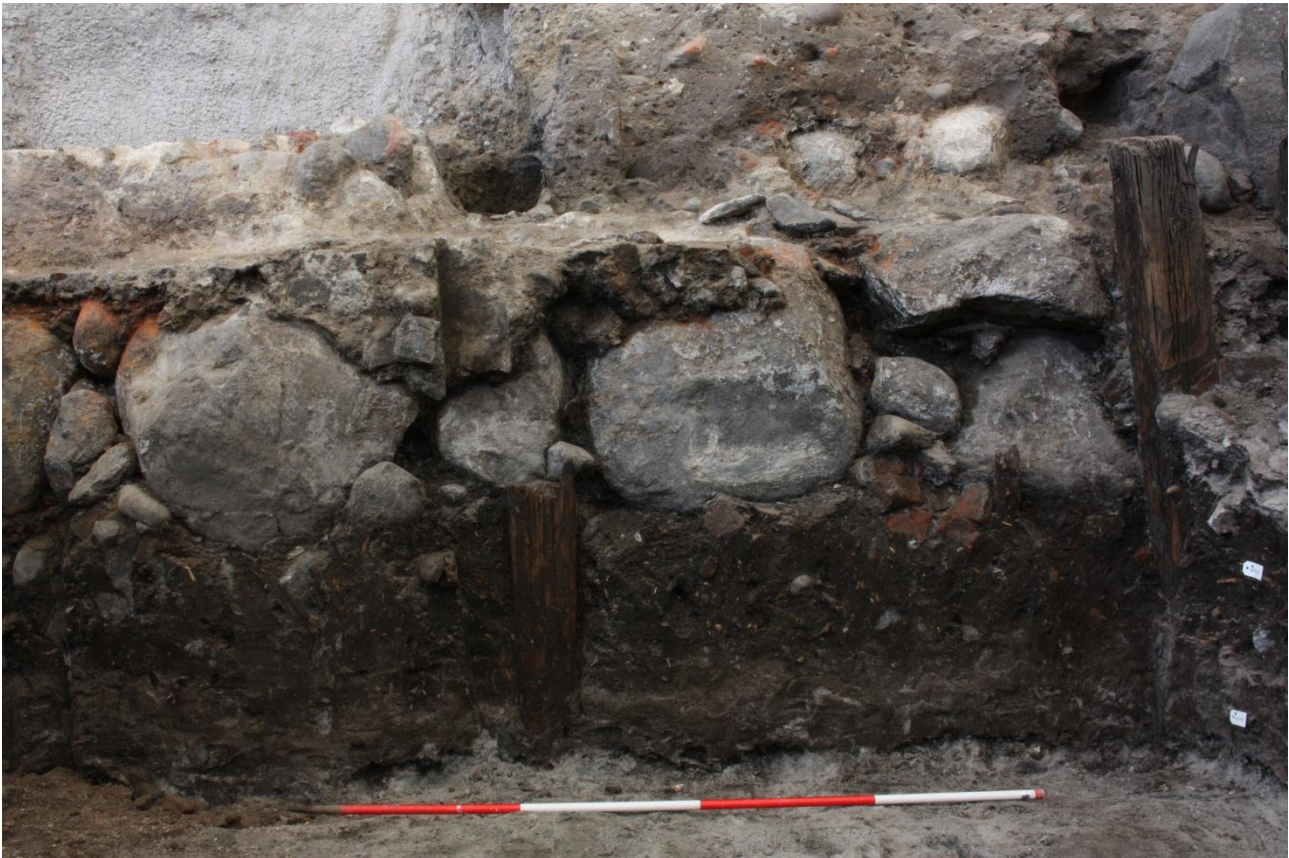
Fig. 44 profile containing sand G101 (at bottom of photo), overlain by SD55781 of Group G678, below SD55780 and SD55779 of sub group 667 levels at western area of Main Excavation. Note that construction cut SC57441 of Phase 2 Group wall G532 truncated the upper part of bulwark G656. A single post from bulwark G602 is at the right of the photo. Photo C03_20140624_11176 by Museum of Copenhagen.

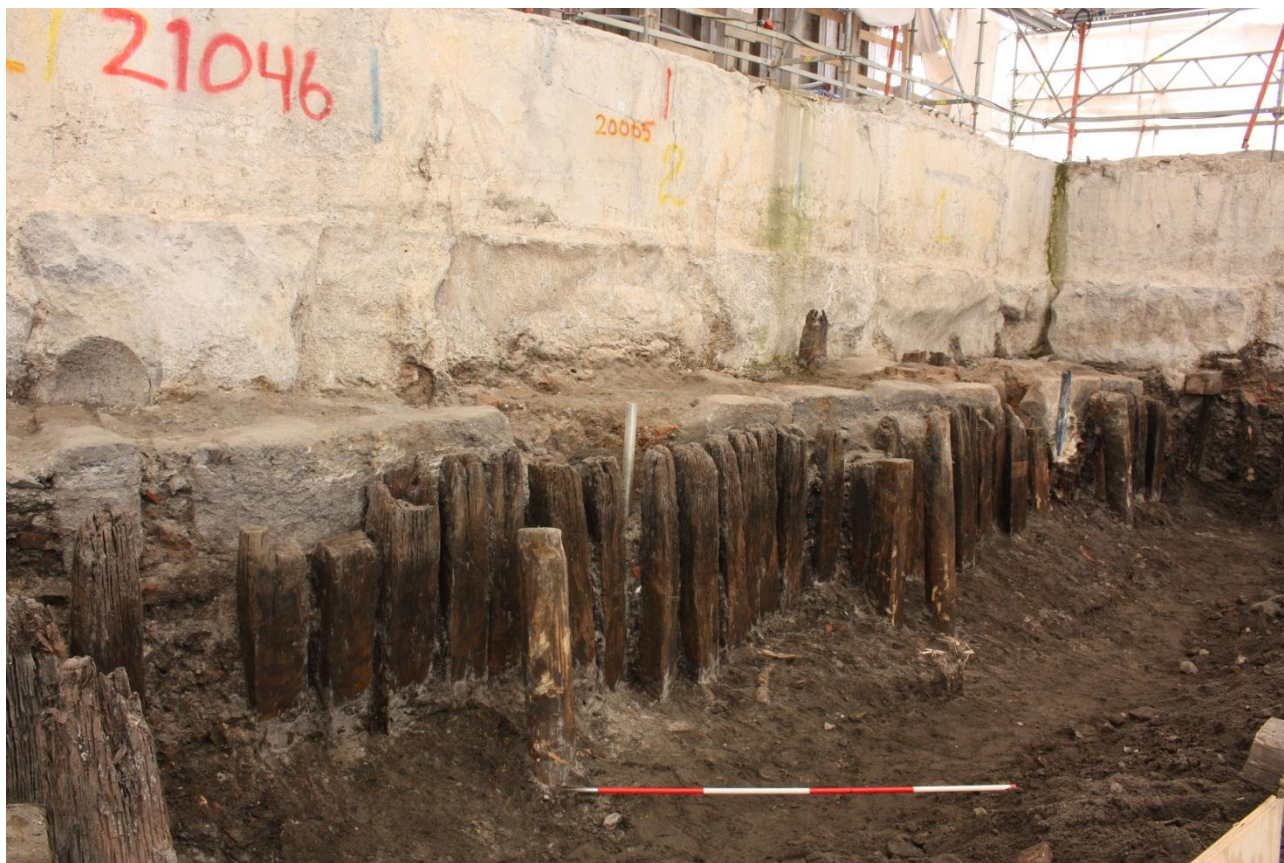
Fig. 45 Photo of Harbour wall group G532 and bulwarks group 602. Located at the eastern end of the Main Excavation looking NE. C03_20140602_10517

The stone harbour wall, G532, stretched for 88 m through out the Guide Wall trench and Main Excavations. Historical records state that it was constructed by 1583 and it was in use until the 1690s when the new wooden harbour was constructed. In the western area the stone harbour was in use until the 1630s when a new wooden reclamation box and then wooden harbourfront was constructed. Here, at the western end of the Main Excavation trench, the upper reaches of the wall are demolished and a new harbour is constructed southwards.

The wall was uncovered approximately 1.5 m below the present ground surface in the Guide Wall excavation and between 1.5 m and 2 m below the modern surface in the Main Excavation at an average height OD: -0.24 m at the top of the wall. It survived at a width of 2 m to 2.6 m wide and from 1.5 m to 2.5 m in height. The destruction of the upper wall part leads to an estimation of the original height. It was built within a linear construction cut with steep sides and flat base truncating the remains of the Late Medieval harbour, structures and deposits.

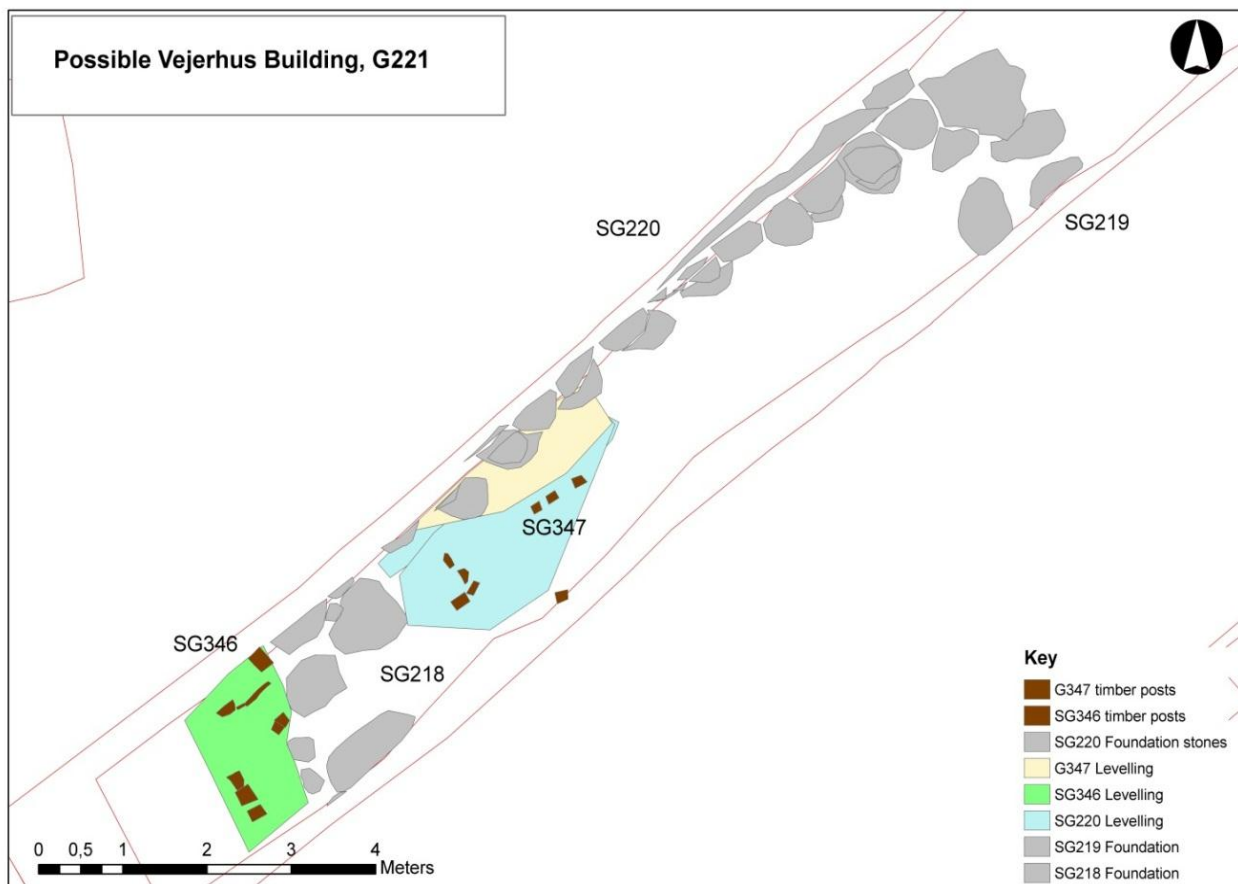
Fig. 48 Plan of possible Vejerhus building, G221. Watching brief phase, 2010

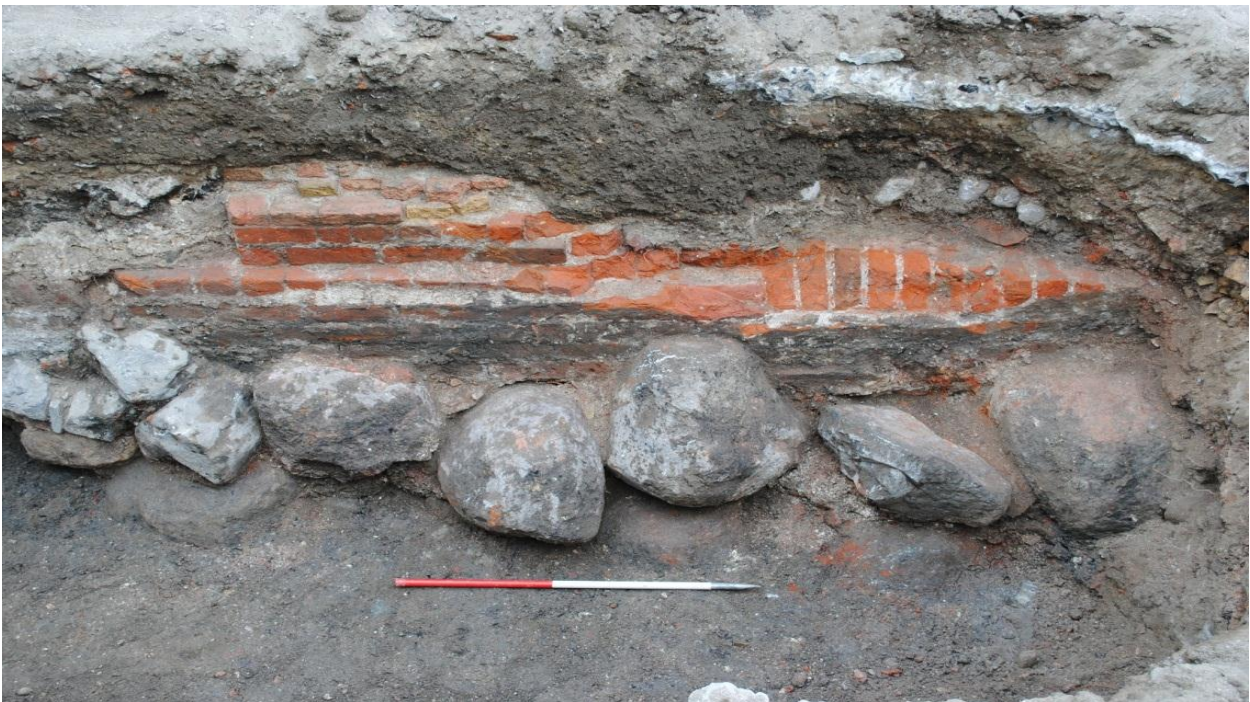
Fig. 49 Northern foundation wall SG220. Comprises Lower course (SS4298), upper course (SS4350) and overlying brick structure (SS4453) C07_20100729_0318

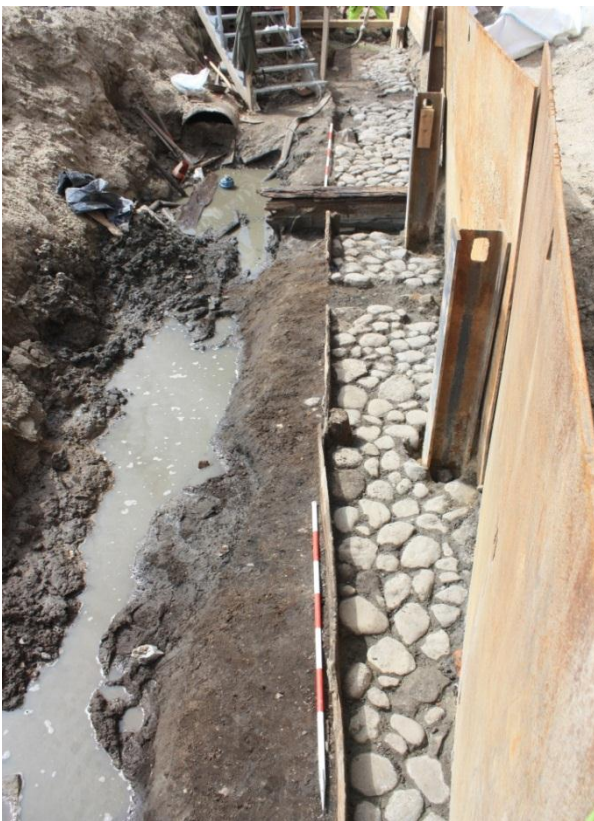
Fig. 54 Working photo of Road Group 430 looking SW in Trench 1 of the Guide Wall trench. The photo comprises road deposit 11789 at rear and road deposit 10493 in foreground. C03_20120723_5083

The harbour path/road, G430, was found in fragments within Trench 1, 2A and 3 in the Guide Wall Excavation. It was greatly truncated by later culverts and land ties from Phase 4 and modern truncations in Phase 6. The road spread over an area measuring 74 m, of which 24 m of the harbour road was seen. It was located at the average height OD of 0.55 m.

The road surfaces appeared to represent a harbourside road dating from the 16th and 17th Century. This was suggested from the stratigraphy and from the finds, i.e. clay pipes and pottery, embedded within the surface. Unfortunately the wood was too fragmented to be used for dendrochronology. The construction cut for the road truncated the construction deposit for the known upper reaches of Renaissance quay wall group G532. It was presumed from the artefactual evidence that the road construction occurred in the same phase as the harbour wall. Although the road was quite narrow at 1 m wide it was found to continue into the northern boundary of the Guide Wall trench. It is of the opinion that the road was wider than what has been exposed leading into an area not seen from excavation.

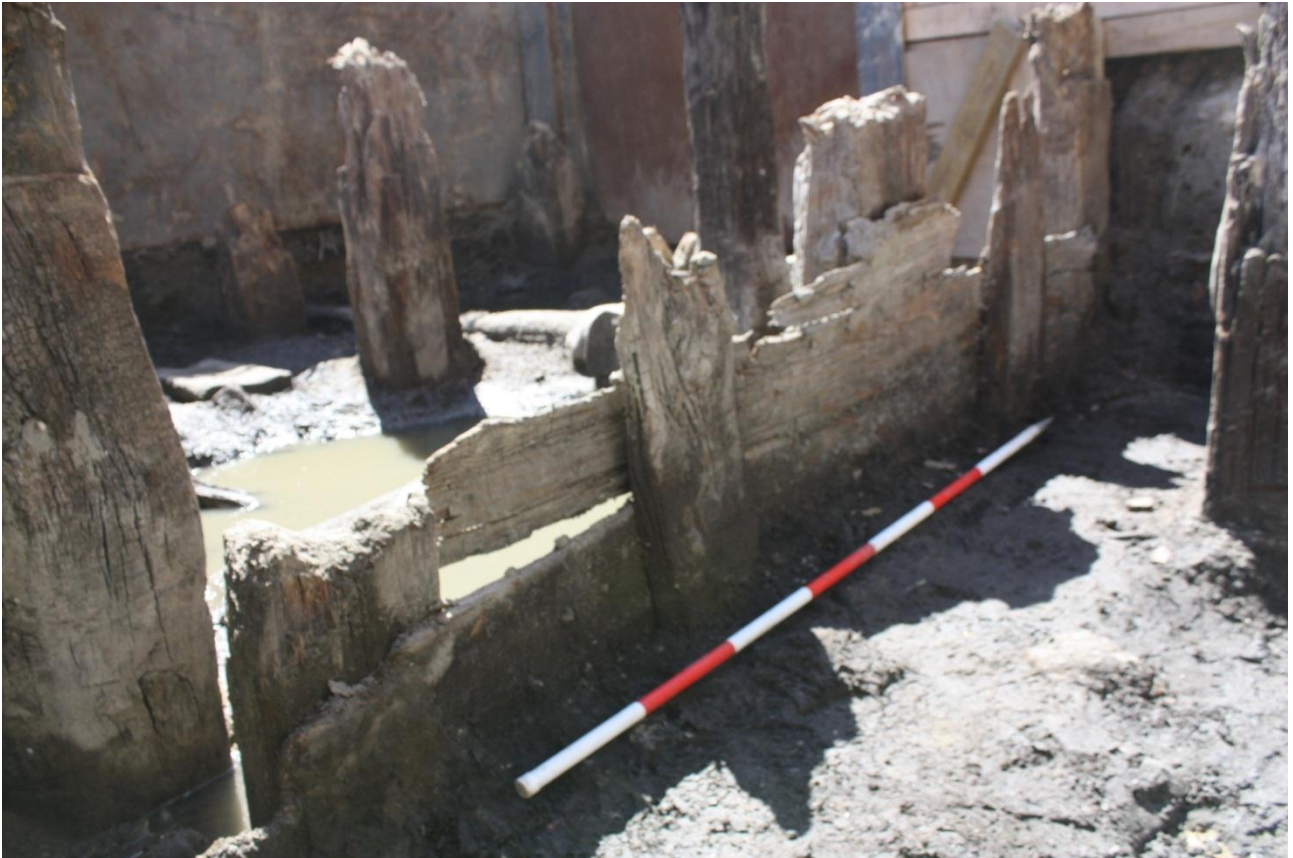
Fig. 59 Photo of reclamation fence G406, looking SW. Guide Wall excavation 2012. C03_20120725_5207

The top of the western section of the fence, G406, was uncovered at 0.8 m OD. It measured 2.72 m by 0.75 m and was exposed to the depth of 0.6 m. The group comprised 5 vertically set posts and a horizontal plank to form the fence. The use of the fence G406 was short-lived but still long enough for the formation of alluvial/usage deposits created to the south, as seen with G682. This mini phase was short-lived as 4 metres south a proper harbourfront was constructed, built into alluvial deposits and natural sand. The area behind was backfilled with urban waste, as seen from Group G651.

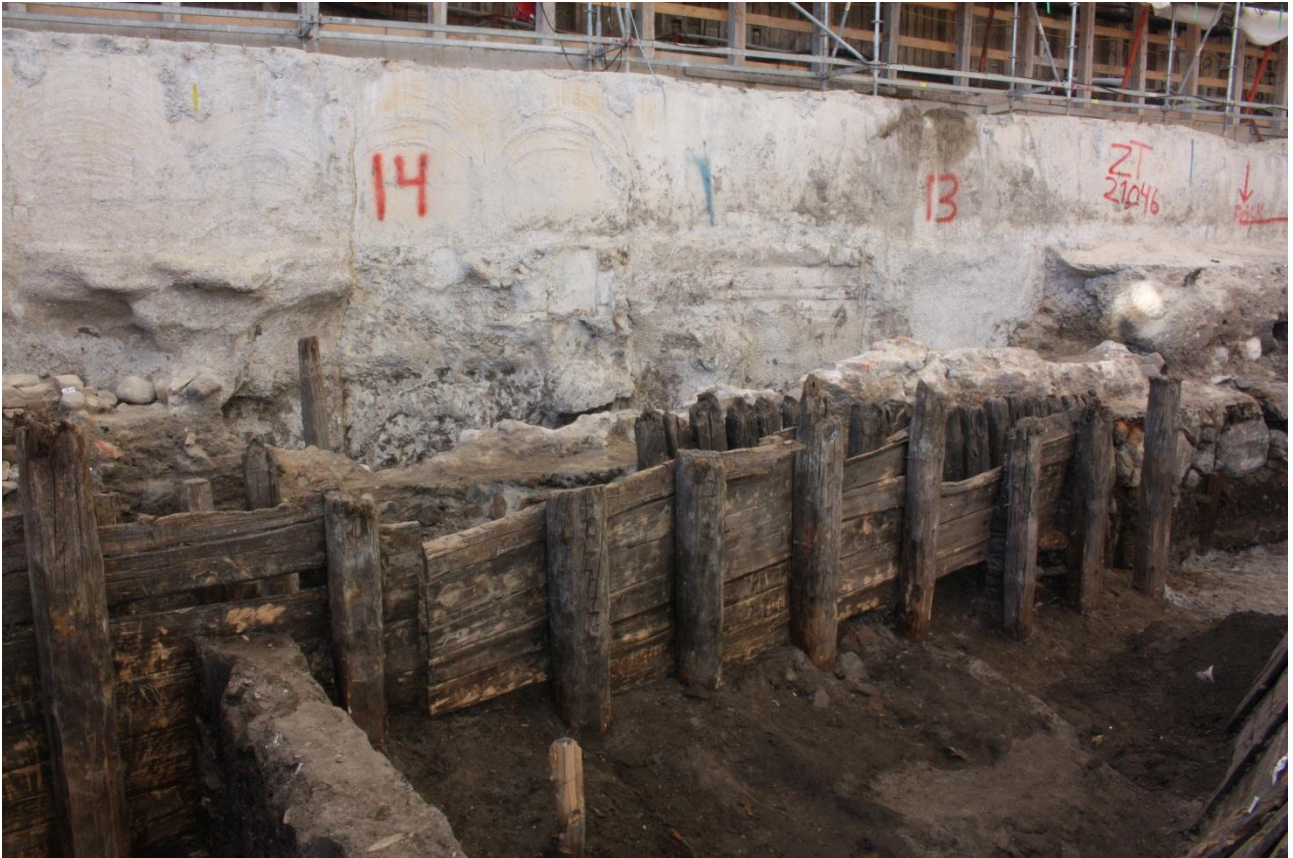
Fig. 60 Reclamation Fence G674, Looking N-W. Note, the bulwark was constructed in two different parts, and that bulwark G602 may have been removed to build this structure. C03_20140624_11187
