Gammel Strand, KBM3828

Cultural Historical Report, Metro Cityring Excavation

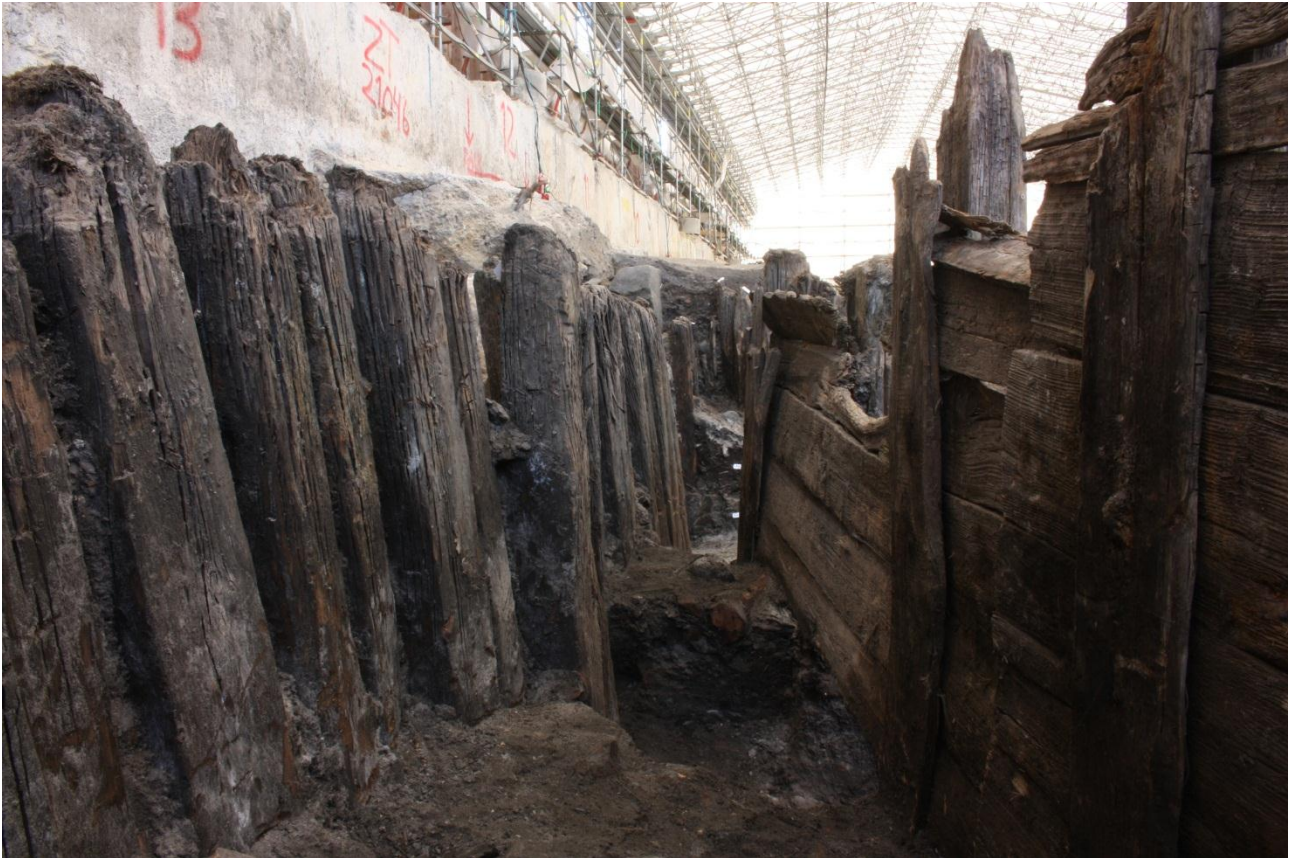
Fig. 61 Working photo of the excavation between G602 and G674 looking NE. Note the majority of the backfill has been removed. C03_20140624_11196.

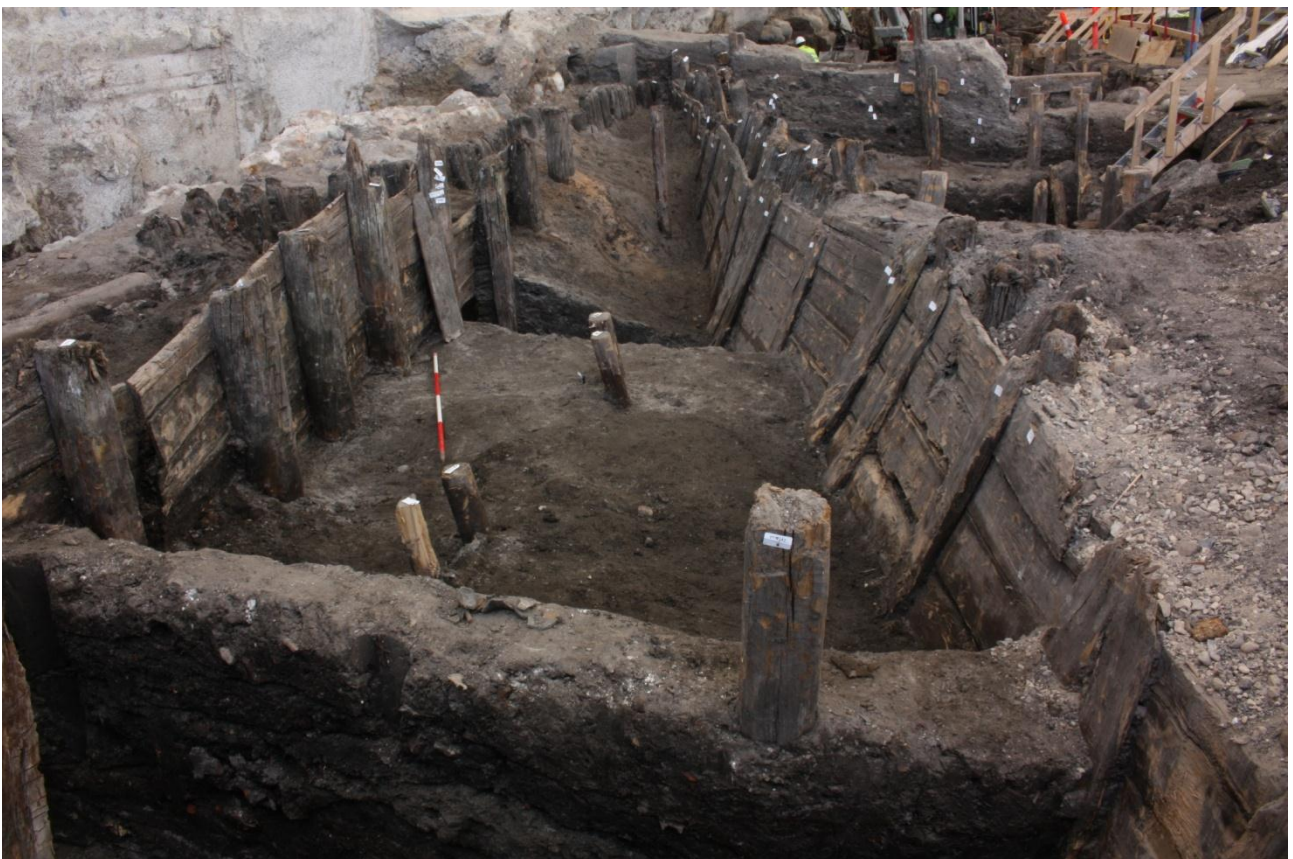
Fig. 63 Harbour wall G532 to the far left of photo, Bulwarks G674 near left, backfill group G640 centre and bulwark G648 right of photo. Looking NW. C03_20140616_10952

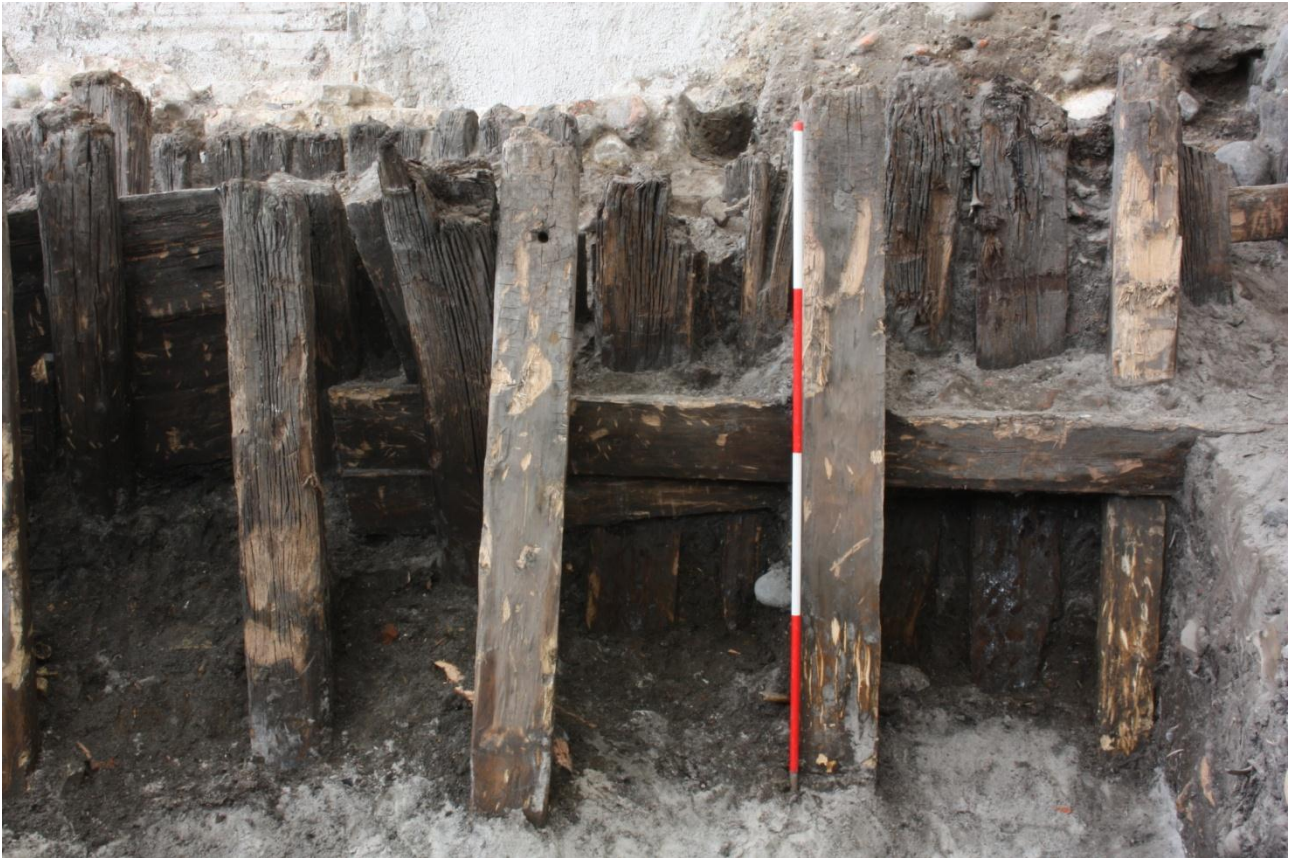
Fig. 64 Close up of harbour bulwark G648 next to the baulk. The photo is centered on an area of repair shown by horizontal plank ST41884 and three vertically set planks (ST39435, ST39413, ST55582) used as the plank's support. The photo is looking N. C03_20140613_10920

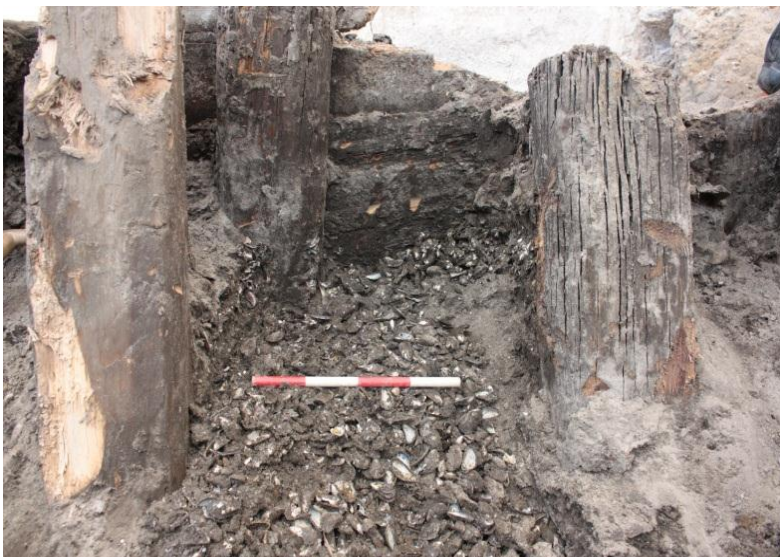
Fig. 69 Deposit SD38150, from G664. Note the large quantity of shellfish from the usage deposit. Looking N. C02_20140526_9538

of almost pure sand, excavated immediately to the seaward side of the southernmost timber bulwark. Where SD38150 met the timbers of the wooden bulwark, clusters of mussel shells were found immediately around the posts. This strongly suggests the area was open to the sea and that this deposit was washed in. The small patches of mid brown silt revealed evidence of many cultivated plants from the city.

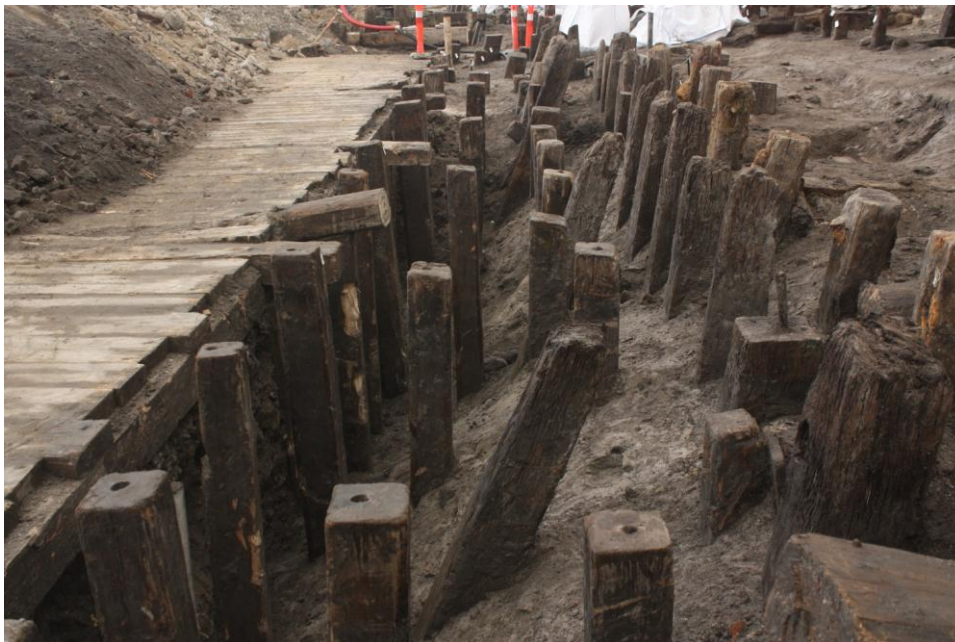
Fig. 92 Parts of Phase 4 bulwark, G626, partly exposed. Storm posts (G595) are seen as slanting towards the bulwark posts. Later structures related to Fiskegangen (G583, Phase 5) with peg holes on top. Looking WSW. C03_20140425_9863

The westernmost, exposed part of the Phase 4 bulwark was only partly excavated during the 2014 Main Excavation and was grouped as SG604, while the easternmost parts were documented in more detail and originally grouped as G626. Likewise the storm posts grouped as SG606 and SG595 were probably parts of the same overall storm post structure in the western and eastern end, respectively. Late in the post-excavation process G626 was split into an earlier and a later construction phase, defined as sub-groups SG712 and SG713 respectively. The division into an earlier and a later building phase was based primarily on the later part being relatively well-preserved and evenly structured, while the earlier parts seem to have survived as single posts in between the later ones. Stratigraphical observations were not documented for all timber elements and other construction parts, but in the instances they were, the stratigraphy supports the division. Likewise, a series of dendrochronological samples from selected posts and other bulwark elements were analysed and supported the division, though far from all posts are dated.

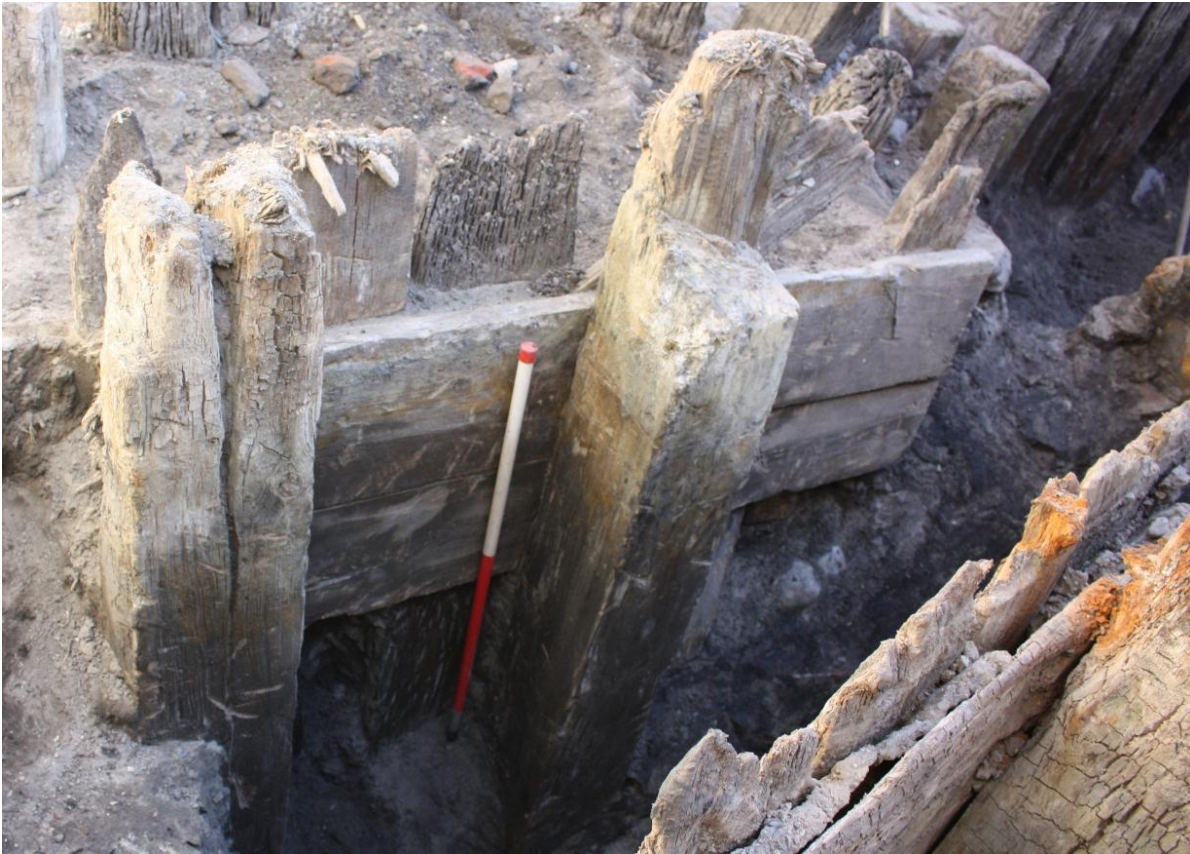
Fig. 93 The easternmost section of bulwark SG713, excavated in the Stairway trench/ZT22798. Looking NNE.
C03_20140723_11702 (cropped)

The exposed eastern part of the Phase 4 harbourfront consisted of an almost invisible first building phase, (SG712, including post holes from deconstructed posts, SG637), which had been almost entirely replaced by the later bulwark (SG713). A number of repairs of the later bulwark was defined and sub-grouped individually.

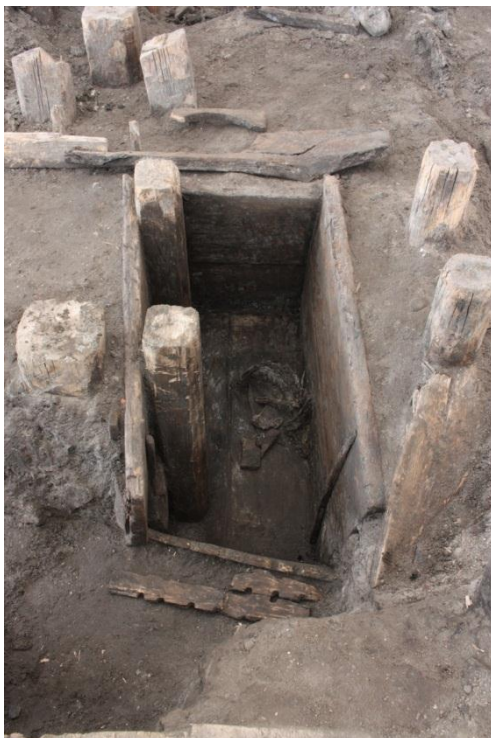
A timber structure (SG618) was interpreted as a partly deconstructed livewell for storing fish. Though the construction sequence was not very clear, it seems probable that the box was built into the north side of the Phase 4 bulwark, when this was changed in the middle of the 18th Century. The structure was preserved below the water level and only the south side of the structure was equipped with holes for the water to pass through, supporting the interpretation that this was a “built-in” structure. The bark or wood container excavated at the base of the structure may have been a bucket or barrel used to hoist fish in or out of the livewell, using the circular hole in the lid or roof of the structure.

Fig. 95 Livewell (SG618) seen towards NNW. Loose timber parts placed next to the box.

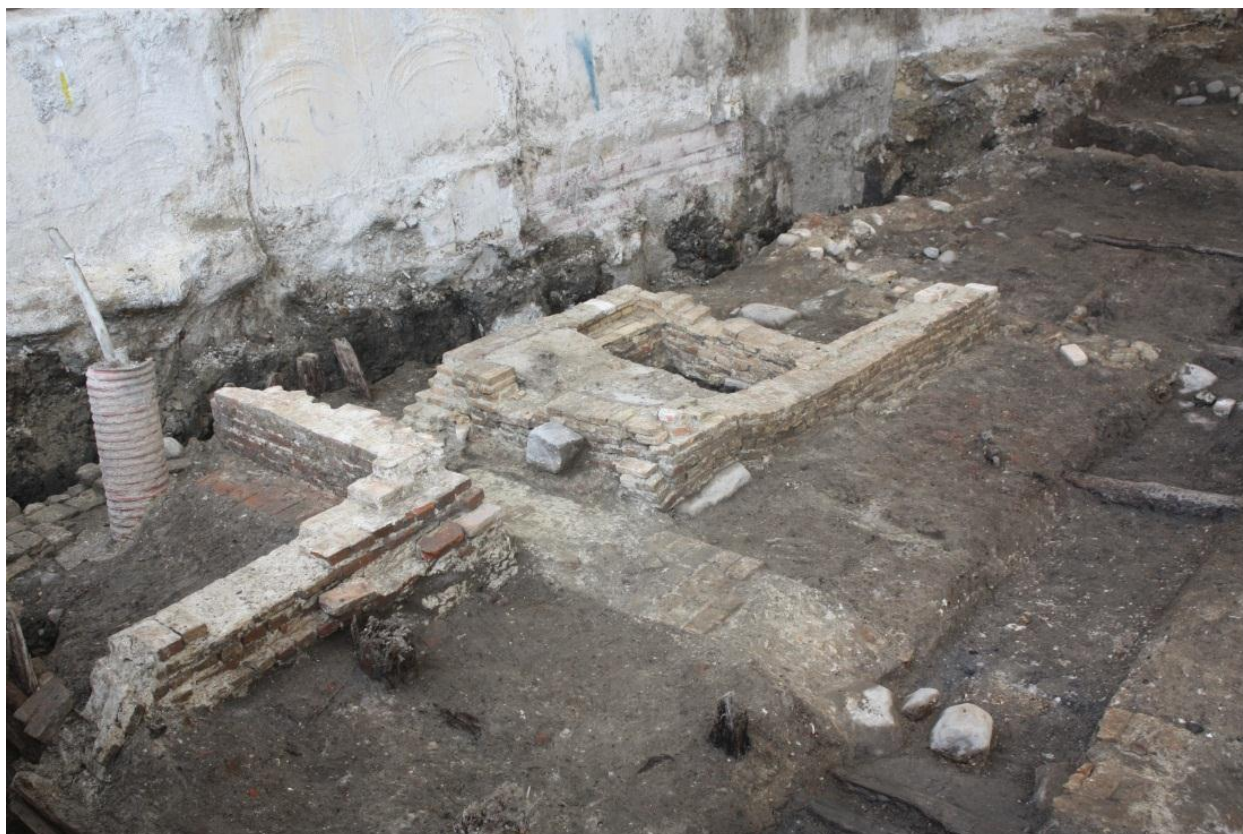
Fig. 110 The robbed out remains of a building (G707), with the remains of the chimney base to the center of the picture, and the remains of a wall belonging to the probable Vragerbros building (G537) to the left. Looking NE. C03_20140226_8277

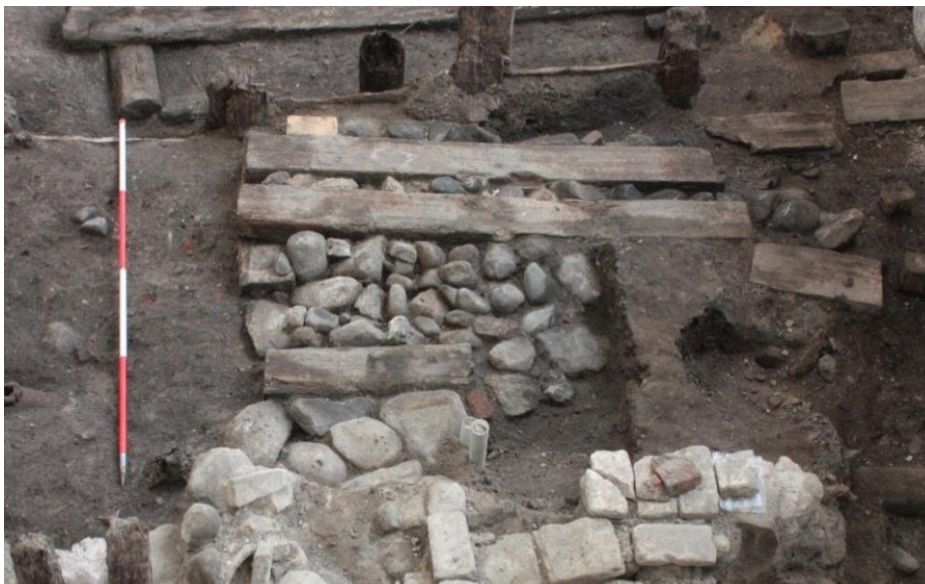
Fig. 112 Timber foundation in the Main Excavation. Looking south. C02_20140507_9194 (cropped)

57). The dendrochronology dates retrieved from the foundation timbers post date the map thereby indicating that this structure was re-built.

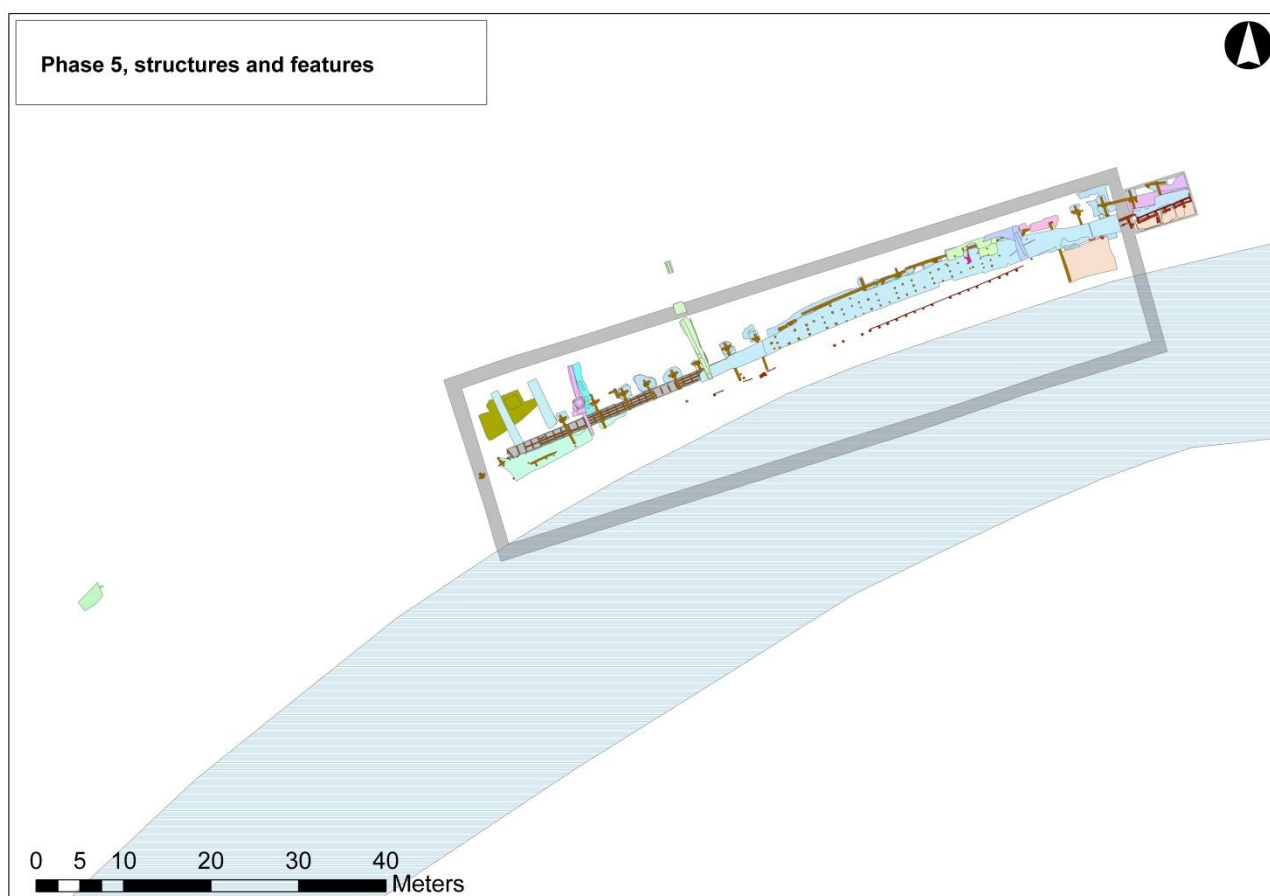
Fig. 116 Plans and structures related to Phase 5

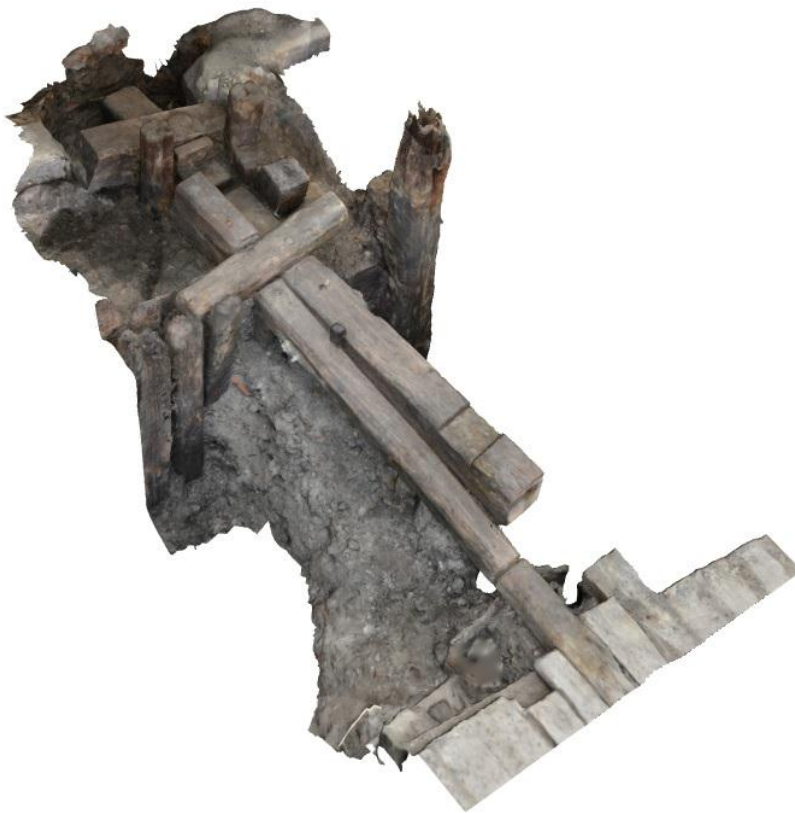
Fig. 120 A photogrammetric rendering of land ties G580 of the Phase 5 harbour and G576 of the Phase 6 harbour, showing how the land ties were related to each other

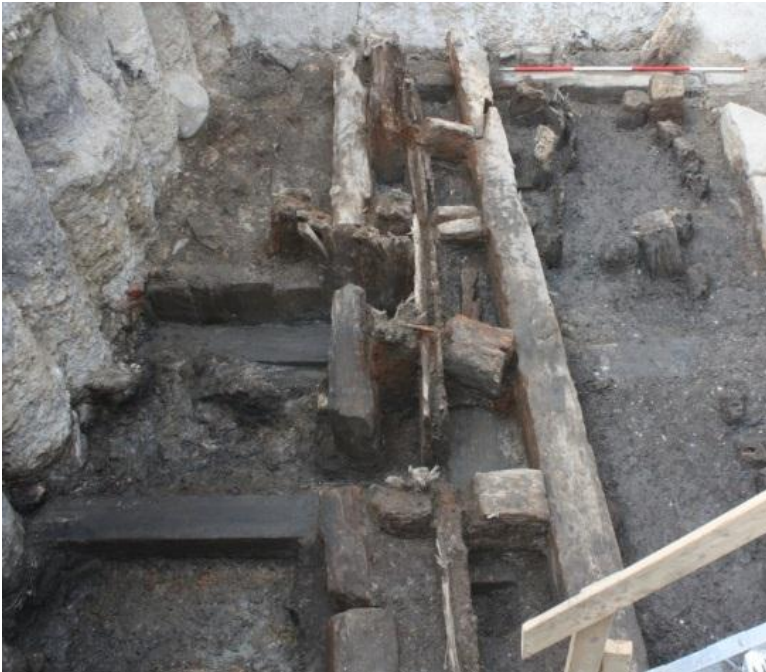
Fig. 122 The remains of the bulwark under excavation in the Stairway trench/ZT22798, looking west. C03_20140403_9295 (cropped)

To the west of the stairway trench, the bulwark was only recorded during a watching brief at the end of the excavation. A row of 19 square posts with planking behind was recorded extending southwest underneath the later 1880s harbour wall foundation.

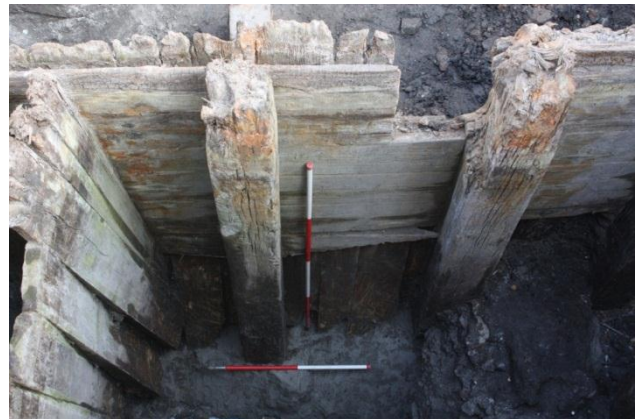
Fig. 124 The excavated planking construction of the bulwark in the Stairway trench, looking north. C03_20140718_11660

Three dendrochronology samples taken from bulwark G591 dated from the mid 18th Century; the planking, ST13627, dated to After AD 1726 (PD212240), one of the posts, ST51252, to After AD 1753 (PD212227), and the southern beam, ST13623, to After AD 1760 (PD208507). One of large bulwark posts, ST28486, had marks incised onto its east facing surface. They were not carpenter's marks, but presumably relate to the construction of the harbourfront in the 1820's.

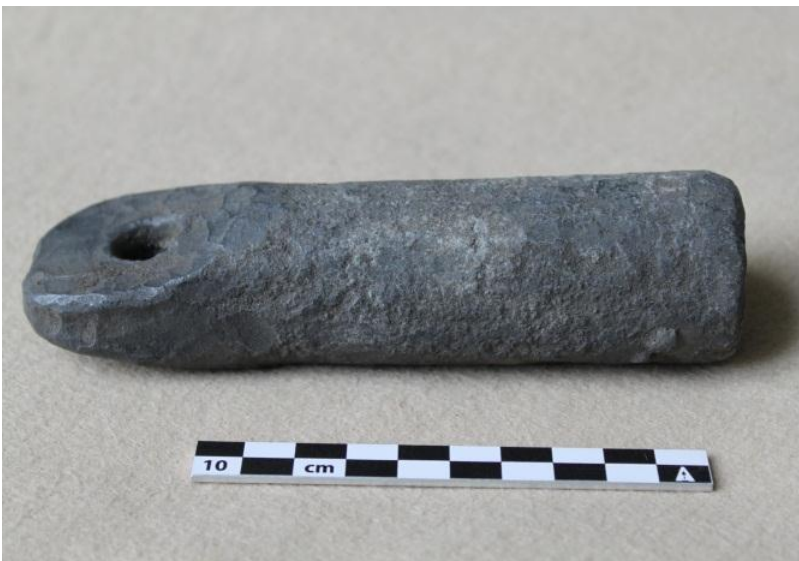
Fig. 130 FO 212461. A lead line to ascertain the depth of water. Recovered from SD53332 (G629)

date between 1800-1900 (FO217954 and FO217953 respectively) and the lead line FO212461. Some of this material is also indicative of the trade which had been occurring during the mid to late 18th Century, with faience which originated from the Netherlands and stoneware from Germany, along with Chinese porcelain among the finds recovered. The 18th Century dates for the bulk of the ceramics could indicate that this deposit derived from previously dumped material which was redeposited here after the *fiskegang* was constructed in 1822-3.

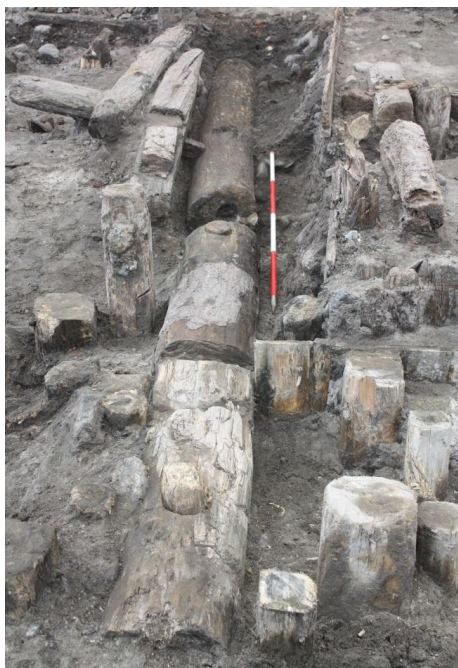
Fig. 133 Drain G231, Looking NNE

Drain G231 was cut through the backfill deposits of the previous phases of harbour development, and also necessitated the removal of stones from the Renaissance harbour wall. To the north, during a watching brief, the feature consisted of two planks lining a cut, although the timber pipe itself was not seen. This could be due to the relative depth of the watching brief and Guide Wall trenches compared to the Main Excavation trench which was c. 0.4 to 0.6 m lower. In the Main Excavation trench, the wooden

pipe was truncated through the middle by a modern gas pipe cut. The southern half, which still retained bark, was sampled for dendrochronology but returned no date.

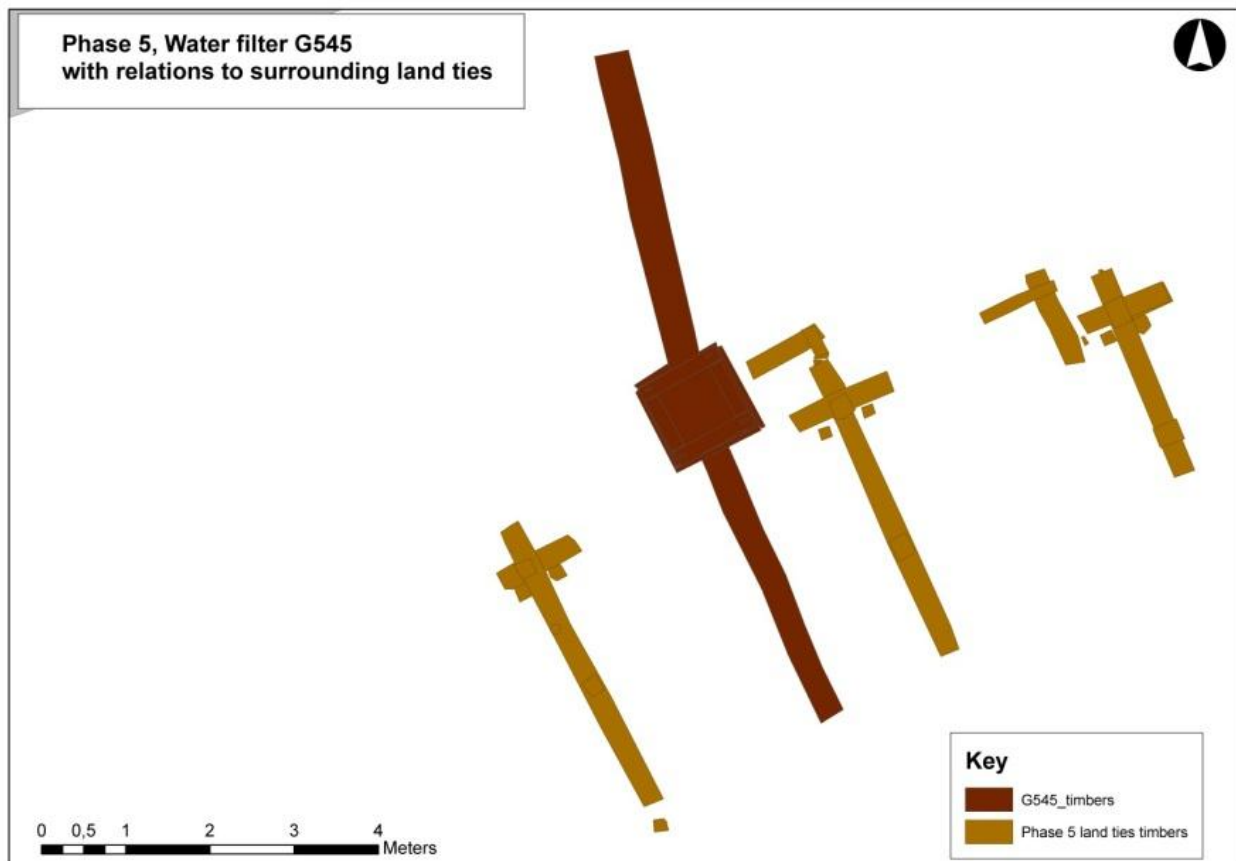
Fig. 134 Plan showing the timber elements of water filter G545 in relation to the surrounding land ties of this phase of harbour development.

The feature interpreted as a water-filter, G545, consisted of a timber box with two waterpipes extending from it; one to the north and one southeast. The box was constructed from four sill beams, into which were jointed four timber posts, one in each corner, with timber planks set horizontally between; four surviving to the south, two to the north and east, and one to the west, and a timber plank floor, constructed of five planks. The lower three side planks on the north and south sides were shaped to fit around the two water pipes, and so the pipes and timber sides must have been constructed simultaneously. The plank floor sat inside the timber sides and was shaped to fit around the posts. The exterior of the waterpipes were packed with blue clay to cover the joint with the timber box to make it watertight.

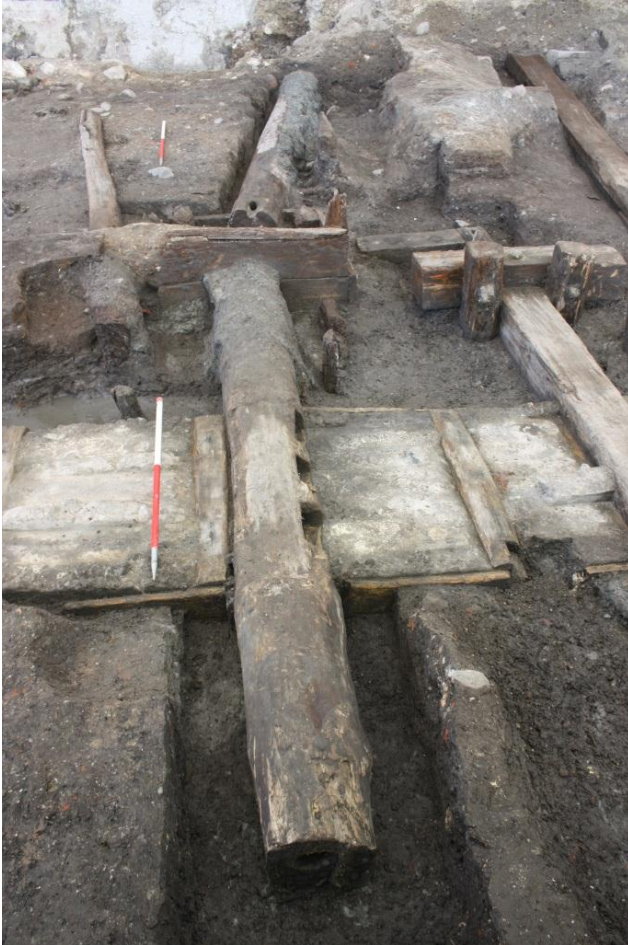
Fig. 135 Overview of the water filter pipes with the timber box between, looking north. C02_20140312_8529

This feature was interpreted as a water filter used to remove waste products from foul water before it was disgorged into the canal, as it is very similar to a structure found on 19th Century plans. This feature could also have been part of a stand-pipe at street level which would have been attached to the small bored hole in the top of the northern pipe. The box 'filter' would then have been used to catch the overspill water

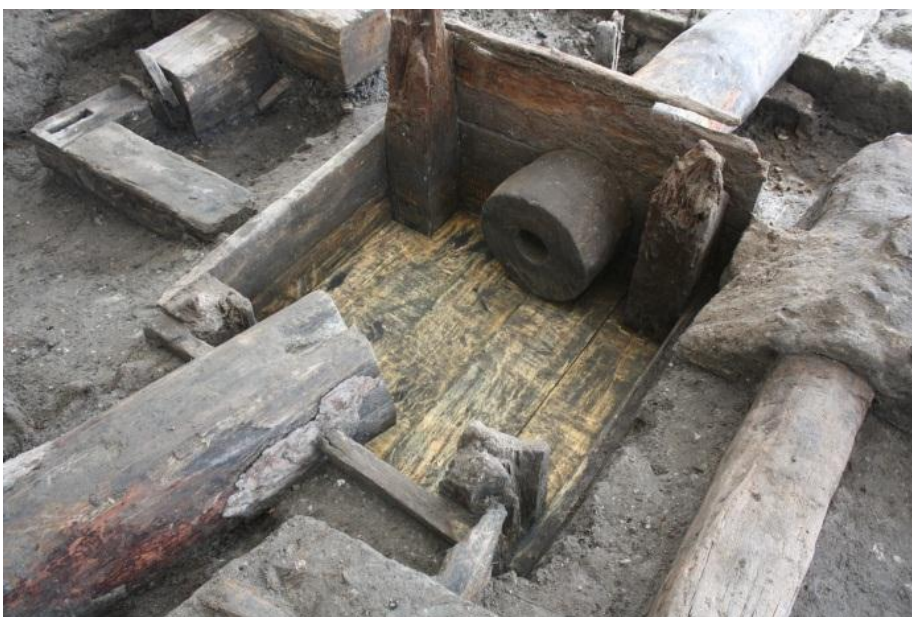
Fig. 136 Detail of the excavated central filter, looking south east. C03_20140314_8795

which was then channelled back into the canal via the southern water-pipe. The cut on the western side could then represent the time when the stand pipe was removed.

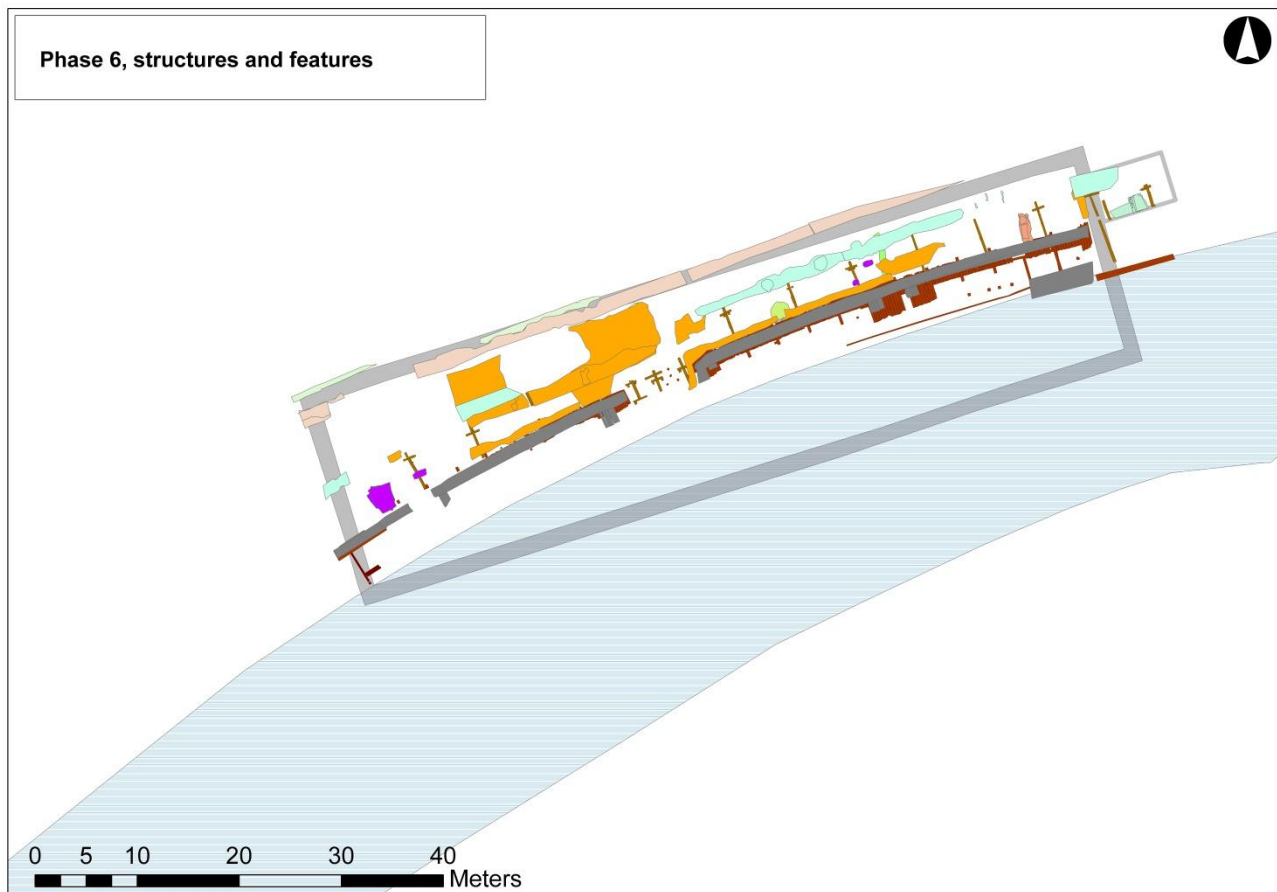
Fig. 140 Plan of all structures and features related to Phase 6

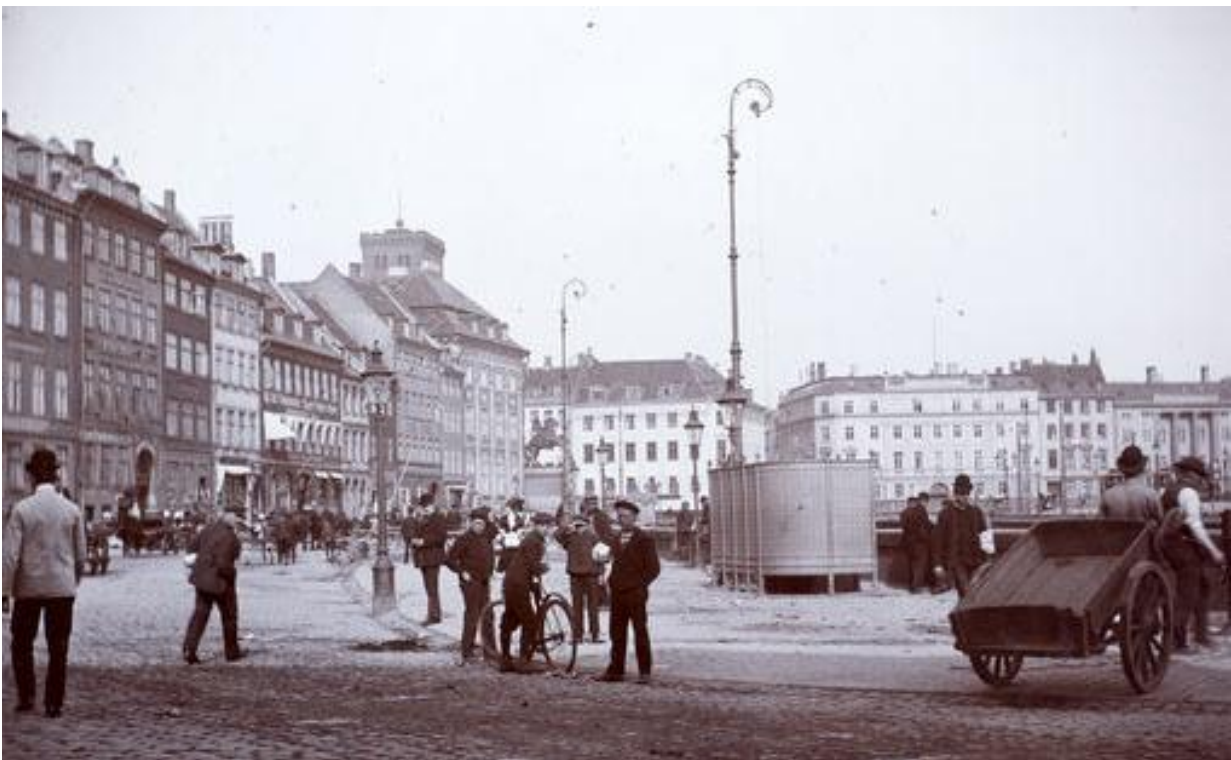
Fig. 149 Photo of Gammel Strand dated to ca. 1908. The shorter, more common street lamps can be seen in the left foreground, along with the tall iron lamps along the harbourfront. Museum of Copenhagen

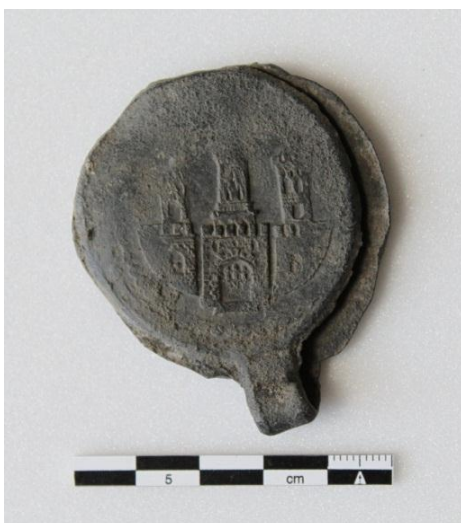
Fig. 152 FO211629. Well preserved lead cloth seal (probably from Hamburg) found in the large levelling dump SD20146 (G636) which covered the entire site. This demonstrates the very mixed nature of the material with a probably 16th-17th Century cloth seal found in a late 19th Century deposit. Museum of Copenhagen

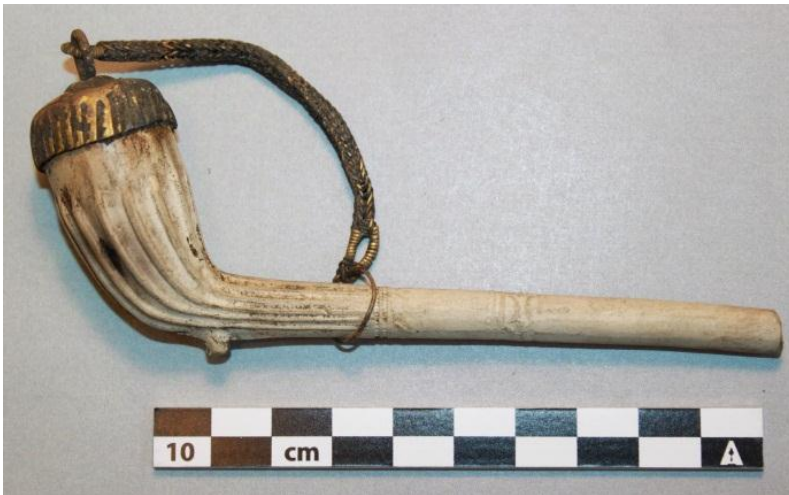
Fig. 153 Clay pipe, FO213419, found in the levelling dump, SD20146, G636. Its design comes from the Schmidt family in Stubbekøbing and dates to around 1740-70. The unusual lid is probably brass which contains four holes and is attached to the body of the stem with a decorative wire. Museum of Copenhagen

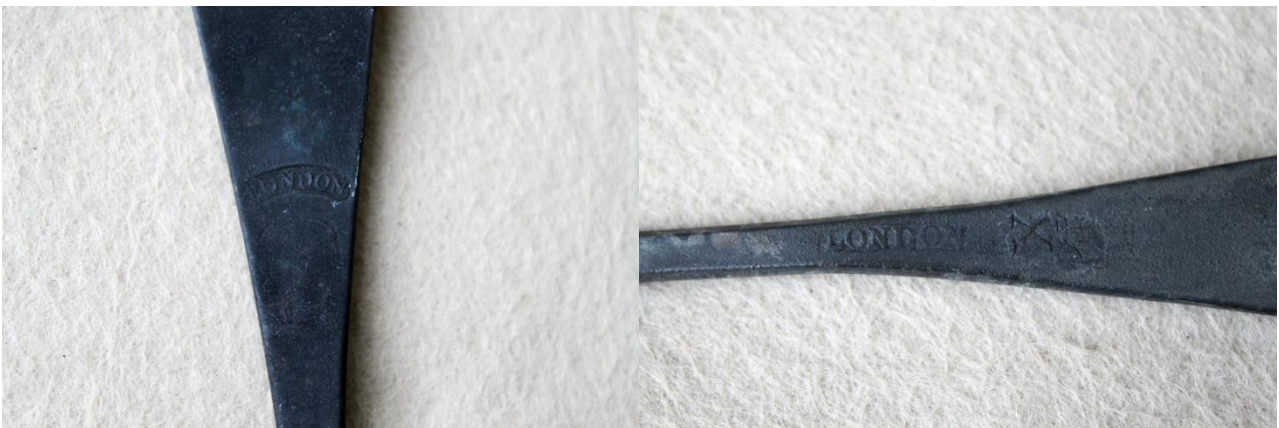
Fig. 154 FO213355 (left) and FO213357 (right). Two spoons with the stamp 'London' on the back, found in the levelling layer SD20146, G636. Museum of Copenhagen

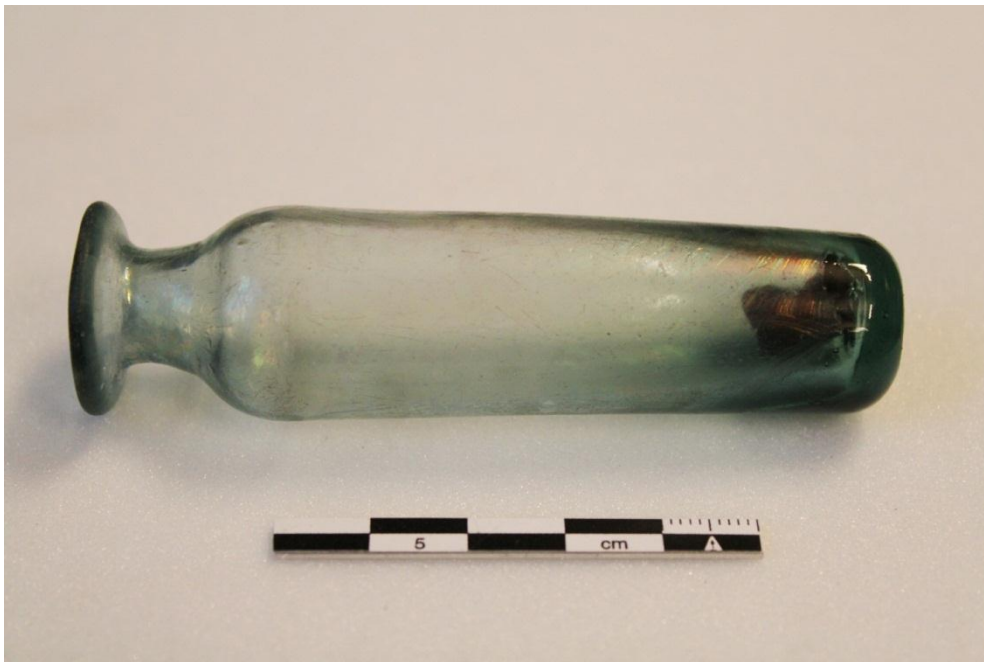
Fig. 155 FO213530. A small glass bottle found in the levelling layer SD20146, G636. The remains within the base of the bottle could be the bottle stopper. Museum of Copenhagen

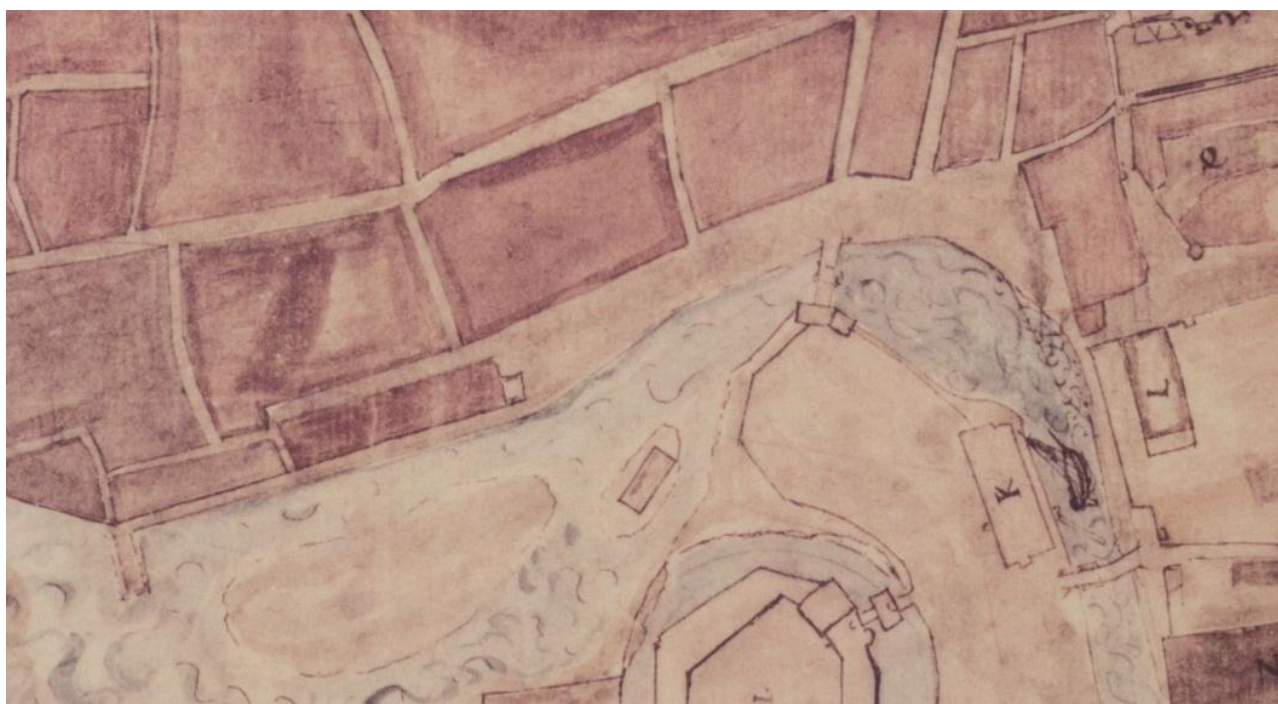
Fig. 156 Section of the earliest map of Copenhagen (cropped and turned) showing the Gammel Strand area. North is almost upwards. Original at the Royal Library

The earliest map depicting Copenhagen is from the years around AD 1600 (based on knowledge of when certain depicted buildings were erected) and the producer of the map and the intentions for making it are unknown. The map shows the main outline of the city with fortifications, streets, churches and few other public buildings. For Gammel Strand, however, only one, rectangular building is shown in the westernmost end of the area (with no signature) and there are no details on bulwarks or bridge structures. The areas around the city are drawn as fields and gardens and the coastal areas – with a different outline than today – are not shown in great detail.

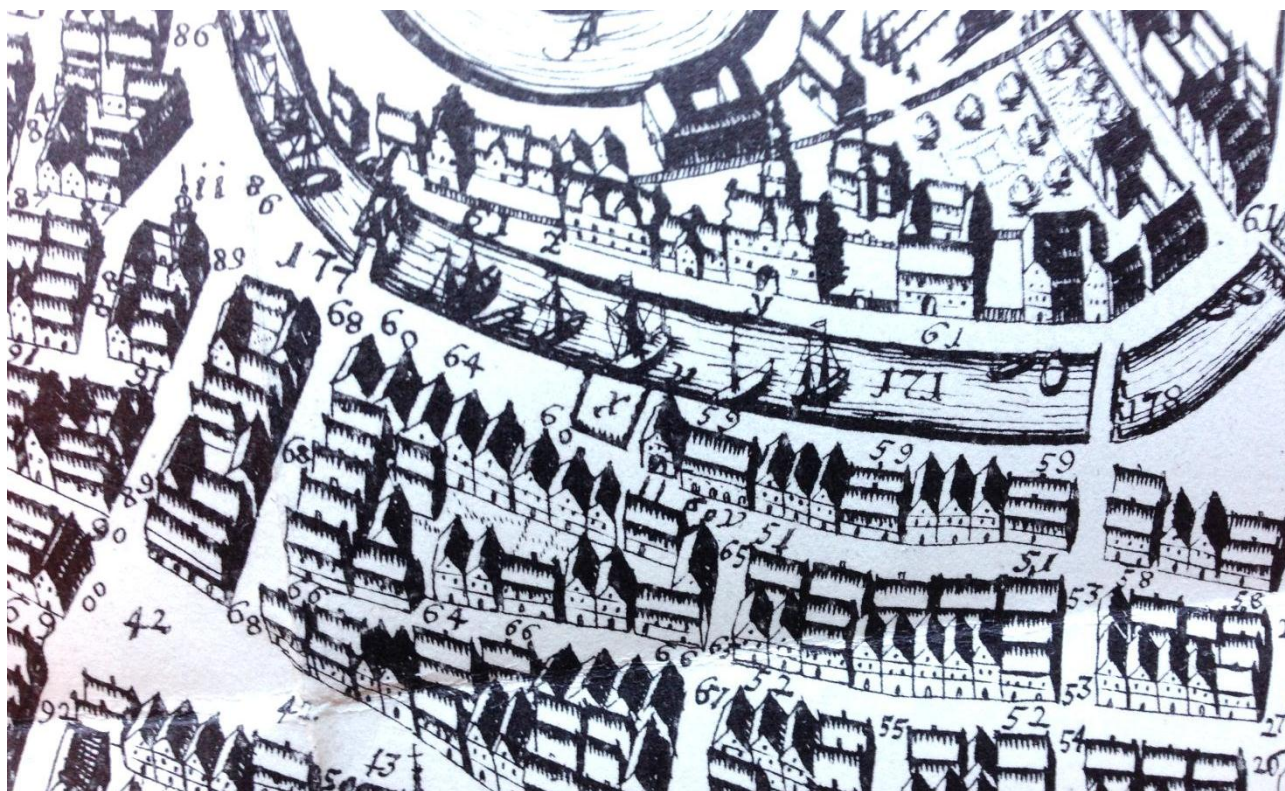
Fig. 157 Resen's map of Copenhagen, 1674. This section showing the Gammel Strand Area. North is downwards. The Danish Royal Library, Kejlbo 1974

Peder Hansen Resen's Map from 1674 is a depiction of both the older and newer parts of Copenhagen. Whereas the latter is not depicted very accurately, with a number of never-realised plans of buildings, it is believed that the former, the older parts of the city, are shown as a more accurate depiction of the outline of streets and buildings – though the buildings themselves are merely signatures than realistic depictions. In the Gammel Strand area, both street names and certain buildings can be identified in the legend, which is written in German. The original of Resen's 1674 map are part of the Resen's *Atlas Danicus*, a collection of copper engravings, kept by the Danish Royal Library and published in part by I. R. Kejlbo in 1974.

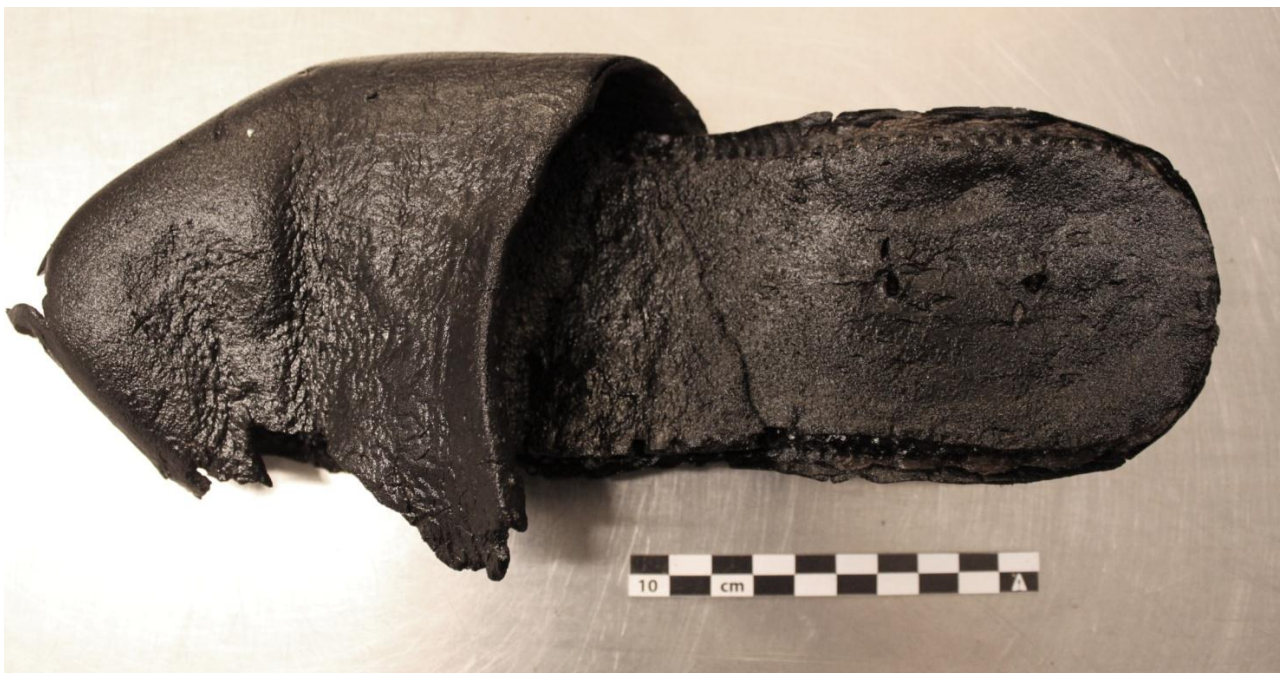
Fig. 164 Mule with wear at the one side of the vamp that could be the result of the wearer hyper pronating or a bunion at the root of the big toe, FO218268. Photo: Museum of Copenhagen
