Gammel Strand, KBM3828

Cultural Historical Report, Metro Cityring Excavation

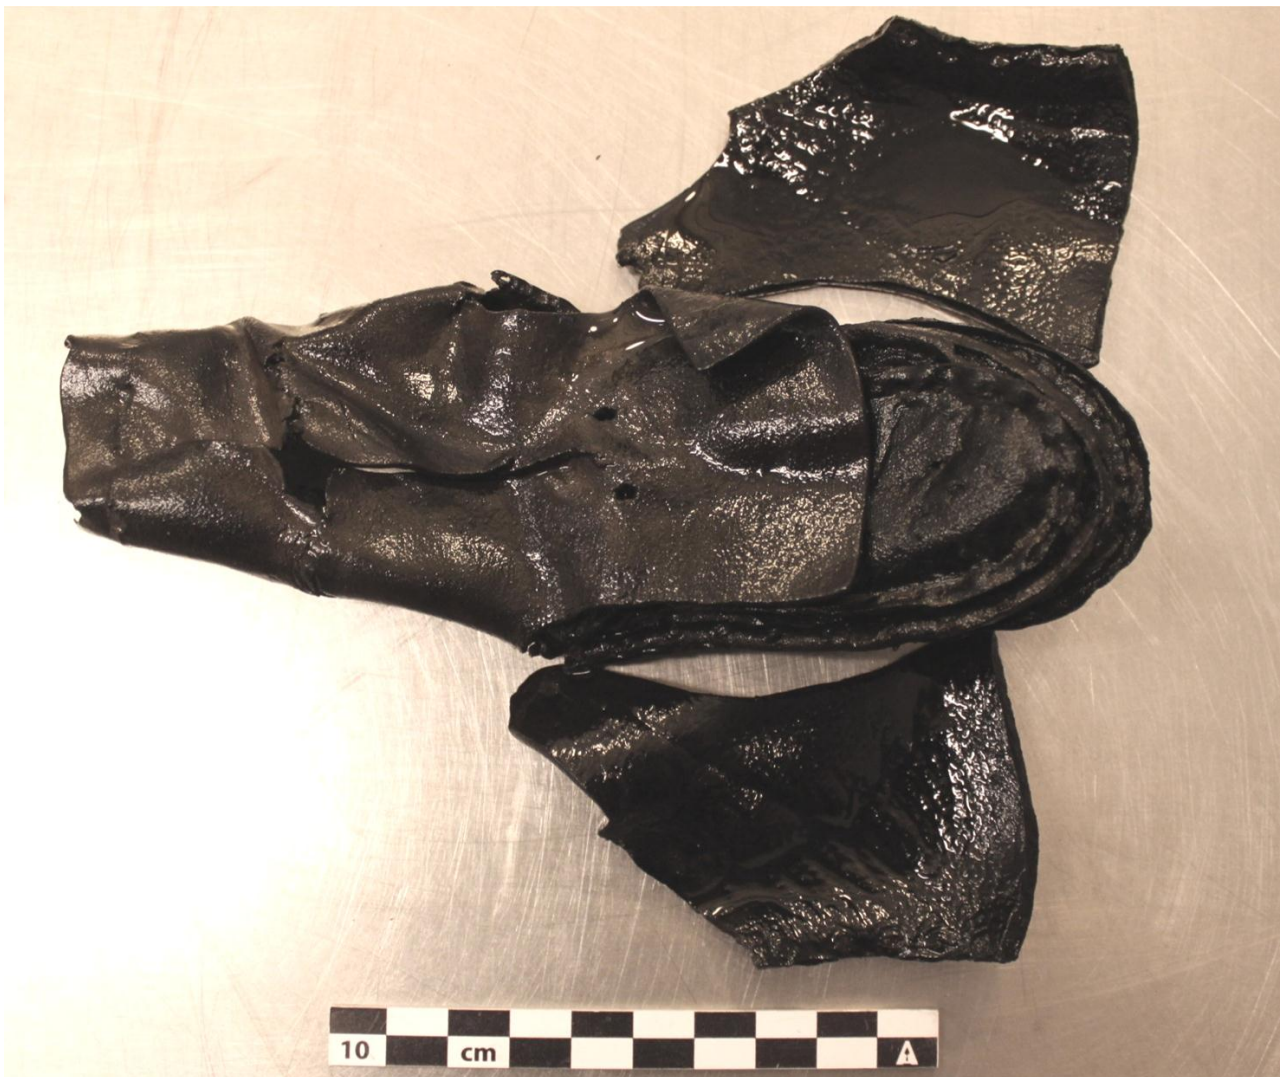
Fig. 165 Man's shoe from the second half of the 17th century, FO218186. A slit is cut in the middle of the vamp, presumably to make room for a large foot or foot deformity. Photo: Museum of Copenhagen.

FO218186 is an example of a shoe from the second half of the 17th century with a slit cut through the middle of the vamp. This feature is seen on other shoes from Copenhagen and was a way to make room in the too narrow shoes for a large or a damaged foot or foot deformity that could not fit into a normal shoe.

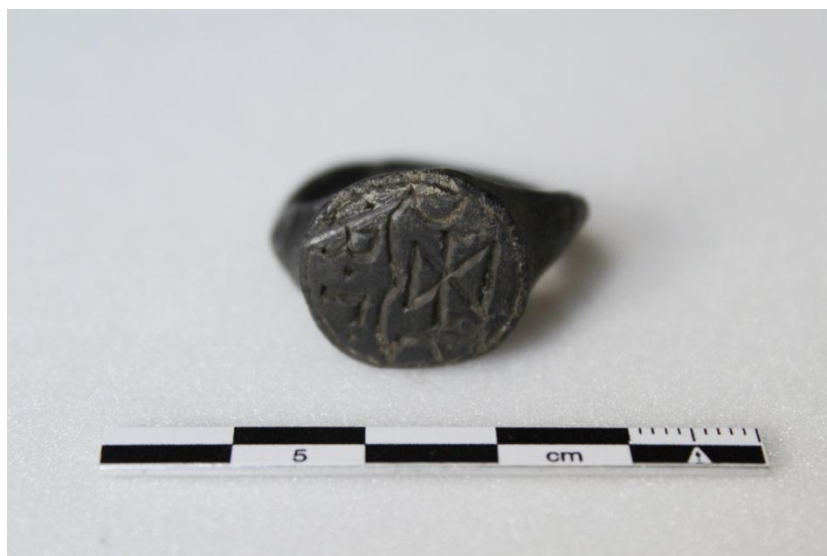
Fig. 166 FO211653 Lead ring with Stamp SD44563, G651. Phase 3. Pre-conservation photo. Museum of Copenhagen

The example here is a lead stamp seal ring. The lead ring is fairly well preserved, but slightly distorted in shape. The stamp seal has a reverse depiction of * L * B * followed by a wave, followed by a marker's mark of two reverse triangle split by a line and flanked by half moons. The motif is set within a circular band.

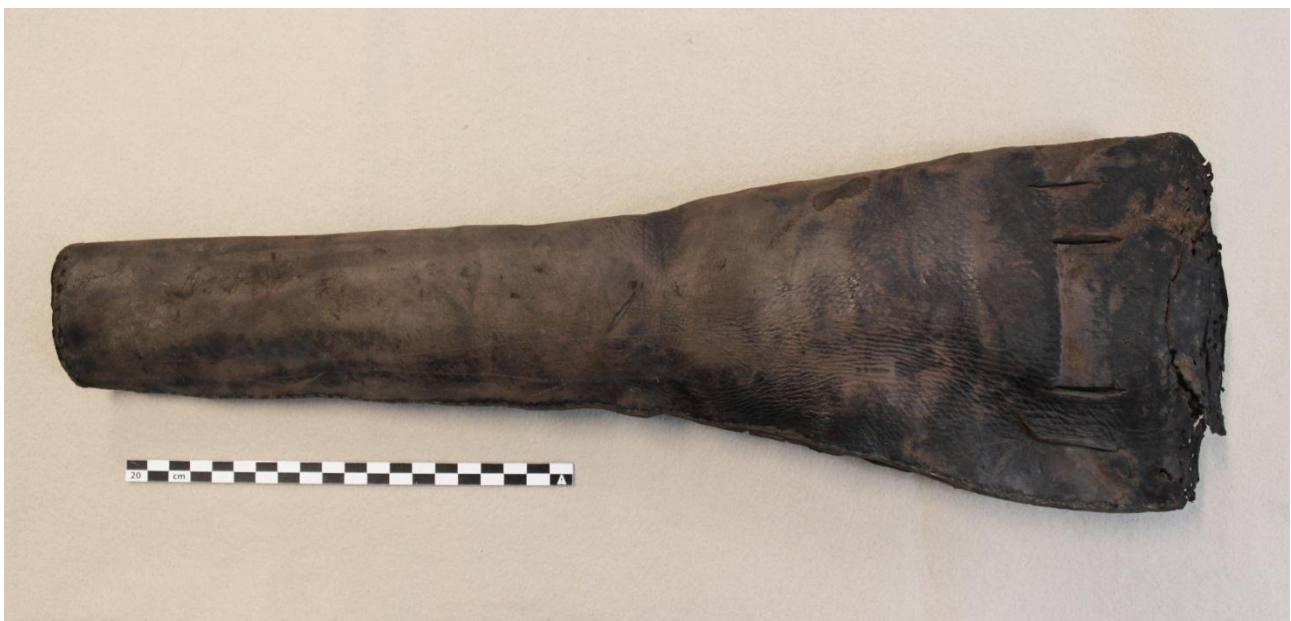
Fig. 167 Gun holster FO213540, SD40474, G664. Museum of Copenhagen

A single gun holster was retrieved from the excavation, representing a former wealthy owner. The gun holster would have formerly been attached to a saddle. Due to the date of the gun holder it is believed to have contained a matchlock gun, (although flintlock guns became available in the 1640s according to Foard 2012, 41). It is not known whether the holster was used for hunting or military use, but the gun holster was linked to the Dragoon type of soldier in this period. The style of this holster, with it being attached to a horse, represents wealth, as horses were expensive to buy and also own. The artefact is produced from only one fragment and it consists of folded-over leather, which is funnel shaped with a rand type seem. The former attachments to the saddle are missing though. The gun holster was retrieved from a deposit thrown into the harbour in the middle of the 17th Century, and due to the anaerobic condition of the soil, it is in a good condition.

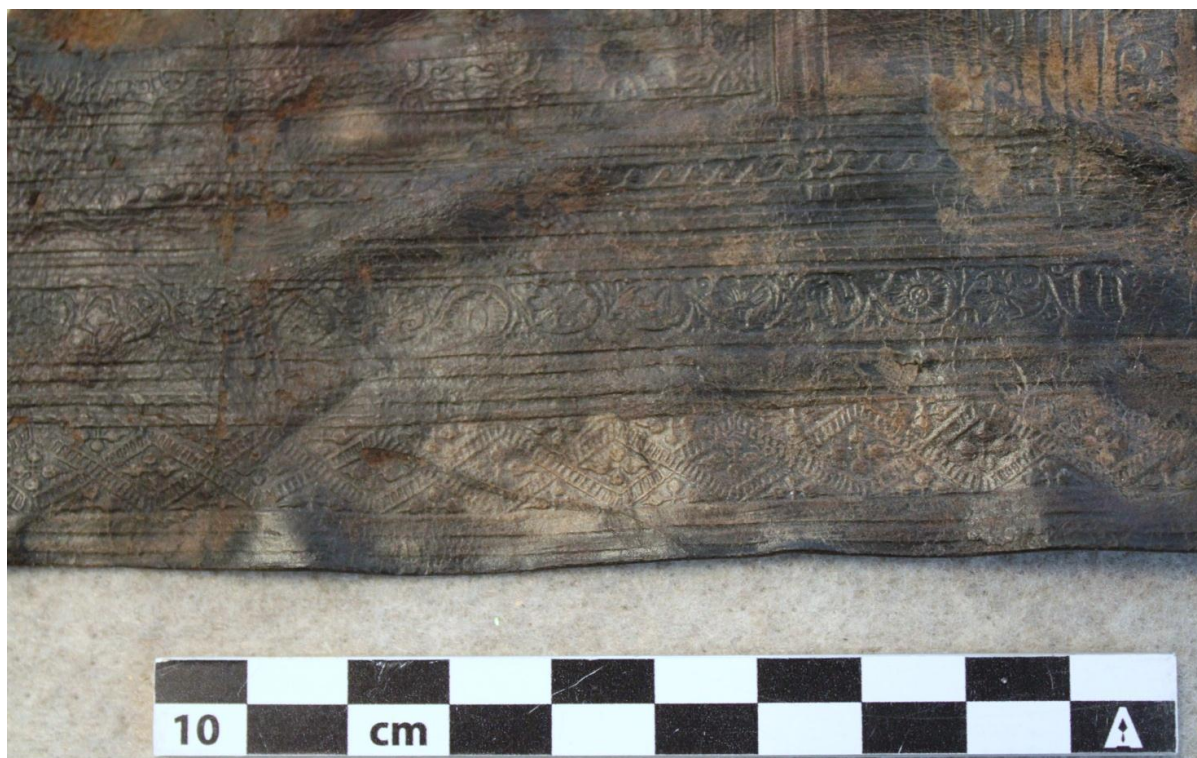
Fig. 168 Detail of book binding, FO213533. Decorated with a variety of patterns in bands. Museum of Copenhagen

One book binding was recovered from Gammel Strand. Some book bindings can be found with both back, cover and bark plates intact and some with only a fragment of one side. The book binding from GLS is not intact and has secondary cut marks. Yet it is easy to see, that the size of the book it once covered was quite large (compared to contemporary standards). The other known finds of book bindings from the Metro Cityring excavations are all quite small – possibly hymn books and small bibles. The book binding from GLS is only about ¼ preserved from one side the cover, but the estimated original size tells us it once covered a more extraordinary type of book. Perhaps related to an institution (church, monastery, city hall etc.). Some book bindings are visually simple and plain. The found example from GLS is on the contrary ornate with advanced decoration in a variety of patterns in bands. See picture below.

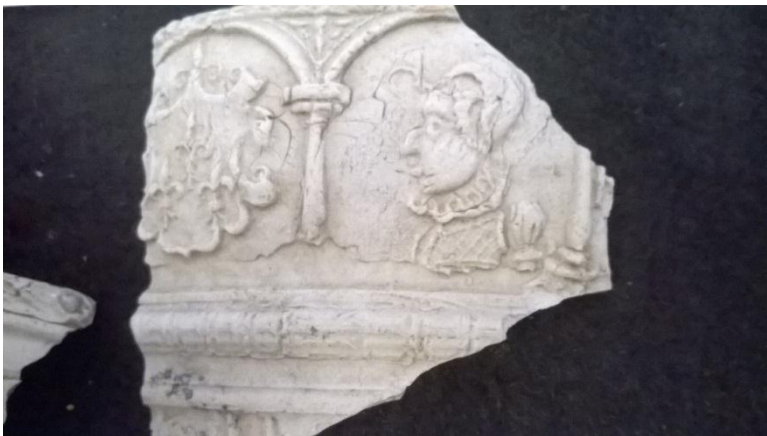
Fig. 170 A fragment of decorated Westerwald ware. FO218800, SD12895, G414. Phase 4. Museum of Copenhagen

A fragment of Westerwald ware is the first example of ceramics and their provenance. The sherd depicts the French King's coat of arms with the three lilies and a profile portrait of a woman dressed in Renaissance dress and headgear. The richly decorated type of jug, a baluster formed jug, was produced in Westerwald, Germany in the first decades of the 17th Century but similar examples from Siegburg also exist. Due to the very light fabric, this may be a Siegburg jug. The sherd shows a Renaissance scene of France with the French style of fashion, which became common all over North and Western Europe. The mould in the depiction was then added onto pottery fired and fashioned in western Germany, and it was then traded to Copenhagen (either directly or indirectly via a transfer of cargo in other harbours. It is probable that it was used by people in the neighborhood of Gammel Strand, and discarded at some point in the 17th Century. It

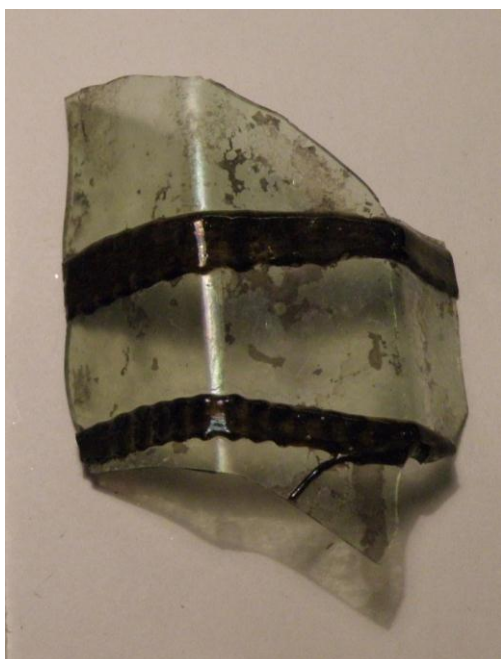
Fig. 189 *Pasglas* sherds with black threads (FO214370). Photo G. Haggrén.

At Gammel Strand *pasglas* decorated by blue threads are almost as usual as the green ones. In addition to that, during the first half of the 17th Century people here have also used *pasglas* decorated by very dark brown or violet, almost black threads (for example FO214370), which are unknown from elsewhere.

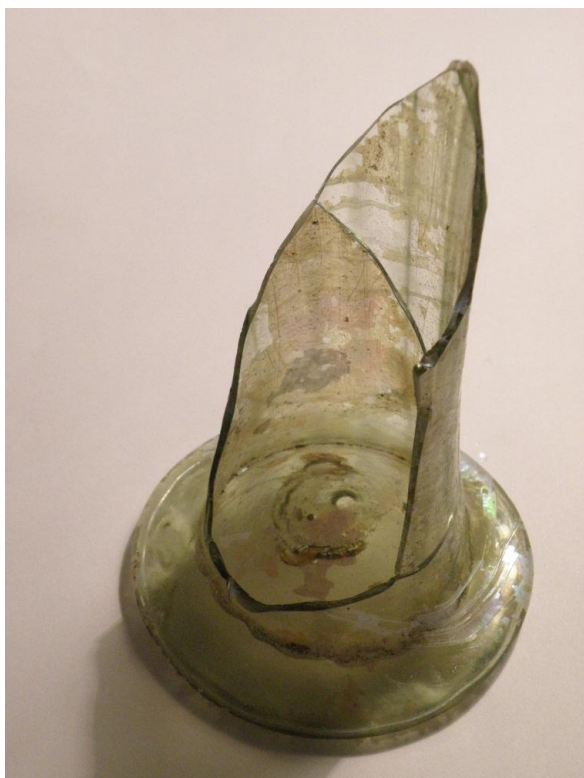
Fig. 190 Fragments of a pedestal beaker (FO214324).
Photo G. Haggrén.

An interesting group among the finds from Gammel Strand consists of fragments of large cylindrical beakers with optical decoration made of vertical rims. These pedestal beakers were made of light green glass of poor quality containing many air bubbles and other impurities in the glass metal. Similar beakers were made in the Netherlands and Northern France but the homogenous group found here indicates a Danish origin. For example, from the castle of Rosenholm as well as the glassworks of Rye in Jutland there are parallel finds dating to the late 16th Century. From Gammel Strand there is also a sherd from a ewer decorated with similar rims and made of same kind of glass of poor quality (FO214295).

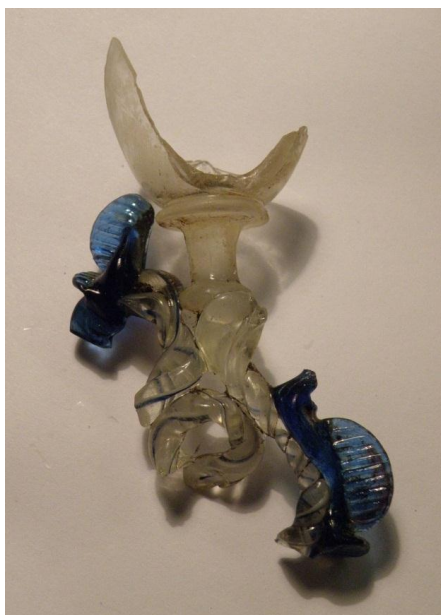
Glass made by the Italian methods in Western and Central Europe was called glass made in the Venetian fashion or *façon de Venice*. Probably best known examples of this sophisticated production are the winged goblets or *Flügelglas*. Winged goblets have a twisted-stem decorated by applied impressed wings and beaks. The stem usually contains coloured filigree canes in opaque white, yellow, red or blue glass. Winged goblets were precious items and were taken care of. As a result dozens of these exclusive items are preserved in European museum collections. It is because of this that sherds of the winged goblets are usually rarely found in archaeology. However, from Gammel Strand there are sherds from more than 15 goblets of this kind. The number is exceptionally high being from one single site but not unique in Copenhagen. For example, a similar number of these finds were found from Rådhuspladsen.

Fig. 191 Fragment of winged goblet (FO214812). Photo G. Haggrén.

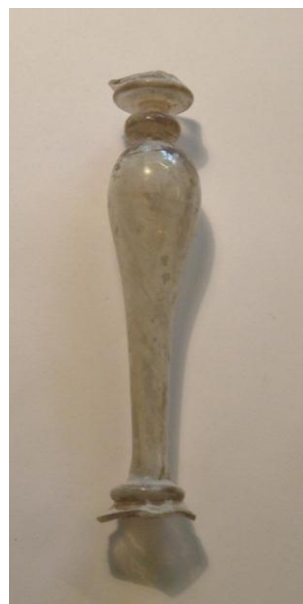
Fig. 192 Cigar shaped stem (FO214535). Photo G. Haggrén.

Excavations in Gammel Strand also revealed fragments of other kinds of glasses, especially beakers and goblets, made in the Venetian fashion. Among the goblet fragments there are, for example, an elegant cigar shaped stem (FO214535), an inverted-baluster stem (FO214377) and a foot with a massive round knob in the lower end of the stem (FO214267). Similar to the winged goblets these colourless wine glasses were mostly used when drinking red wine. When people drank white wine they preferred pruned green beakers, so called *Röhmer* glasses.

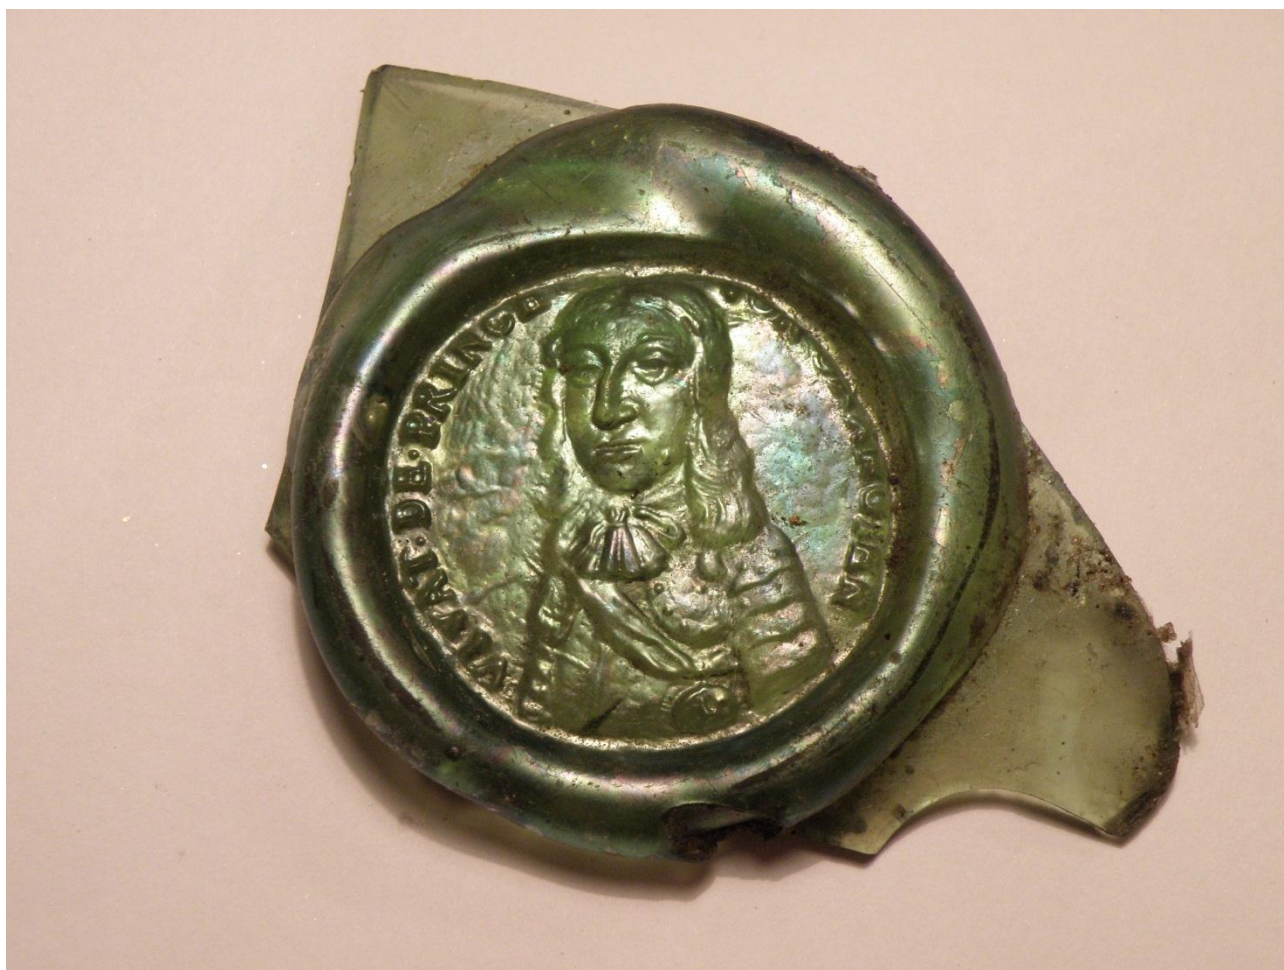
A third seal with an origin in Holstein is from a bottle directed at customers in the Netherlands. This exceptionally large and impressive seal with a diameter of 60 mm carries the portrait of Prince William III who became the Prince of Orange in 1672 (FO214805). The portrait is surrounded by the text "VIVAT DE PRINCE VON ORANGIEN". The Prince as well as the coat-of-arms of the house of Orange-Nassau was very popular motif in seals put on the bottles made for the export to Dutch markets. These seals have been dated to the period before 1689 when William became the king of England. Bottles with this particular seal have been produced in five glassworks beginning in 1669 to the 1680s. This seal is not unique in Copenhagen, there is at least one similar seal previously found in the city.

Fig. 194 Seal with the portrait of Prince William III, the Prince of Orange (FO214805). Photo G. Haggrén.

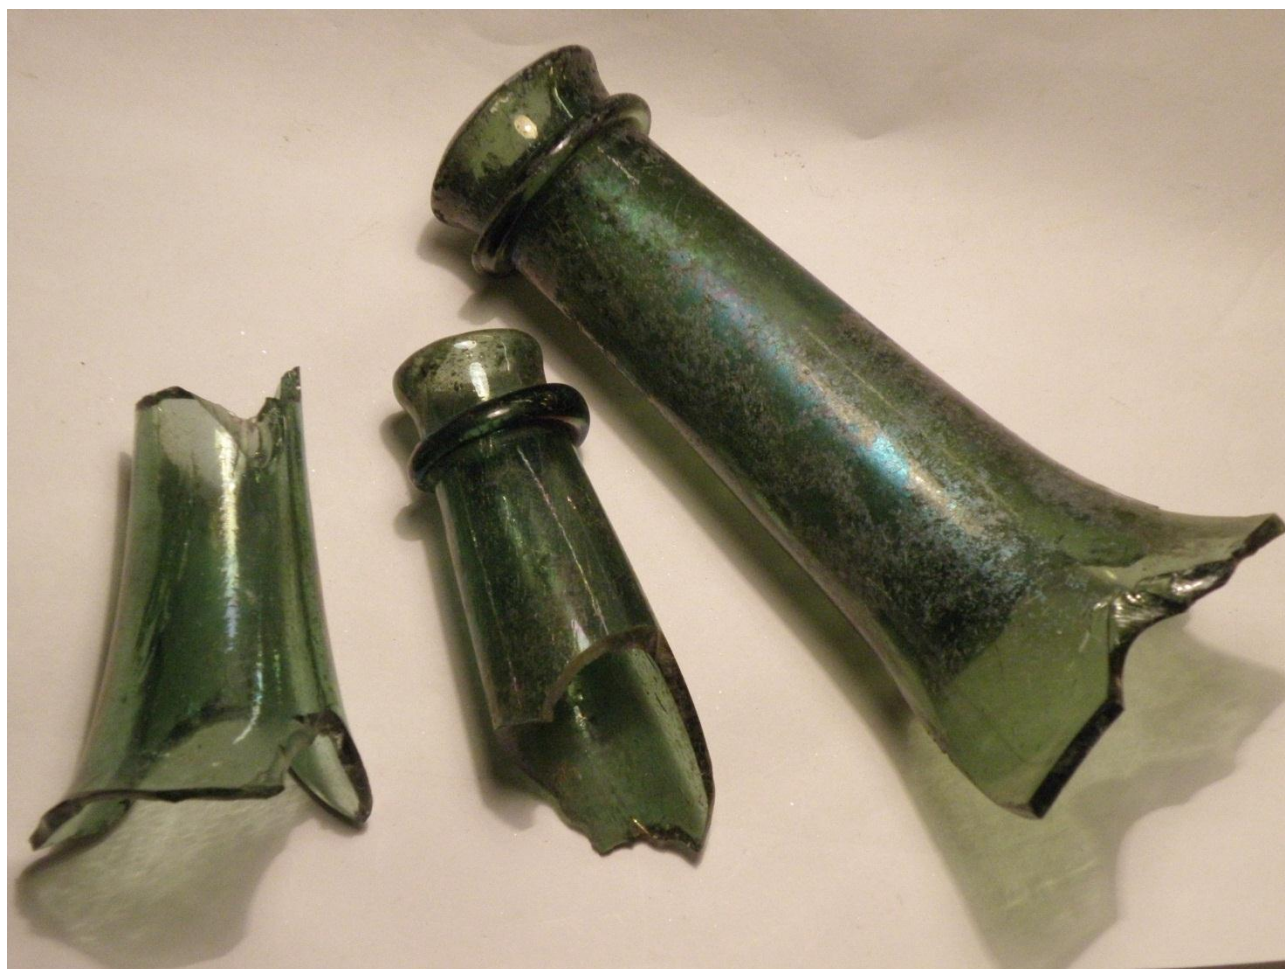
Fig. 195 Three bottle necks from Gammel Strand (FO214194). Photo G. Haggrén.

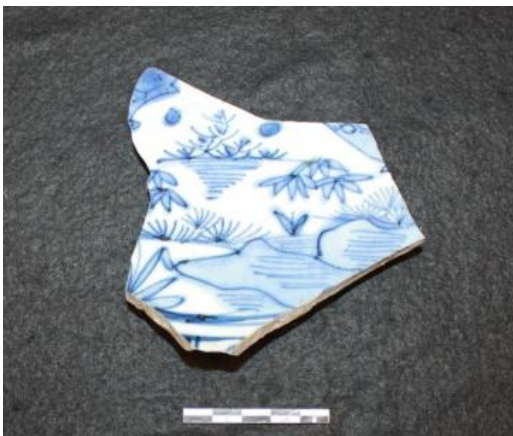
The ware is called *kraak* ware after the Portuguese ship type that were used in the Asian trade and on which the porcelain was carried. The kraak porcelain was produced in the Chinese town Jingdezhen in the period of the late Ming dynasty (1573-1644). It was the first type of Chinese porcelain ware to be produced in large quantities for the European market and exported in large quantities especially to the Netherlands.

Fig. 197 Part of kraak type dish with landscape motif found at Gammel Strand, c. 1580-1650, (FO216366). Museum of Copenhagen

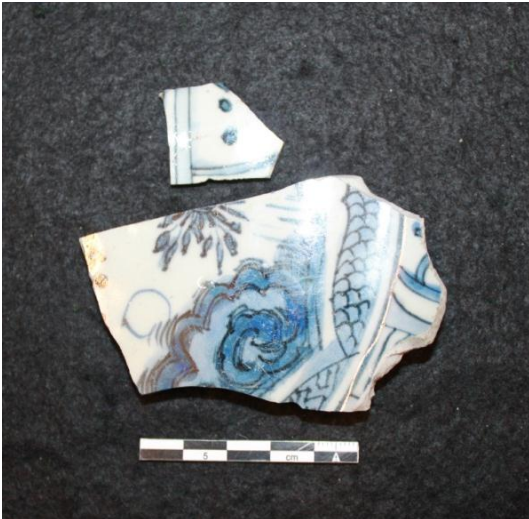
Fig. 199 Part of kraak type dish found at Gammel Strand, with landscape motif and Buddhist symbols, c. 1580-1650, (FO 217949)

The *kraak* porcelain seems not to have been part of the Royal collection and it can only be identified through archaeological findings in Copenhagen. In the refuse layers at Gammel Strand three kraak porcelain items have been found, which is a high number of this rare type (Fig. 4).

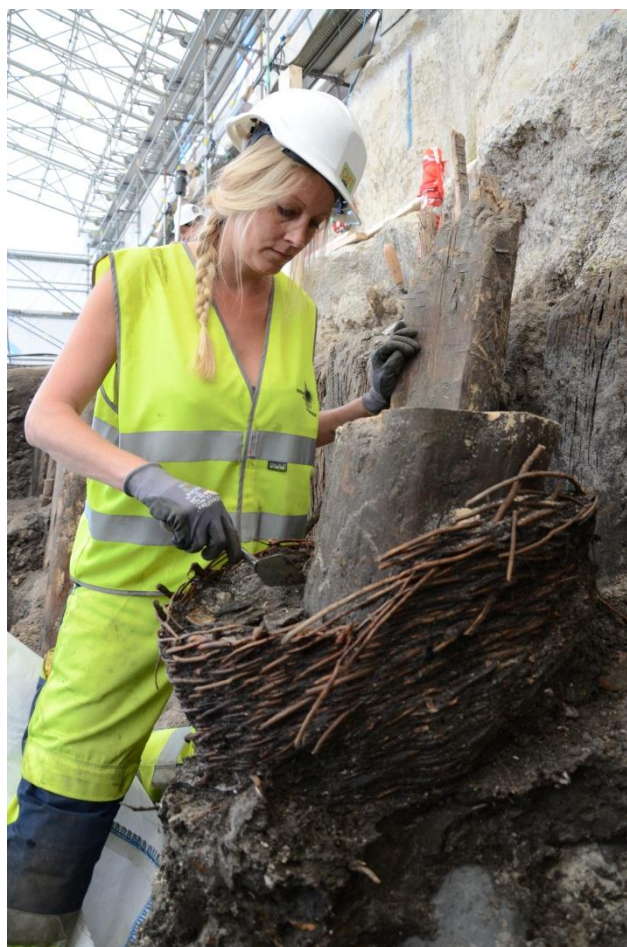
Fig. 202 Storm Post ST34393 (G646) with wicker fish basket F0219487, G646. The upper part of the post had been recently removed to help excavation. K. K. Tayanin

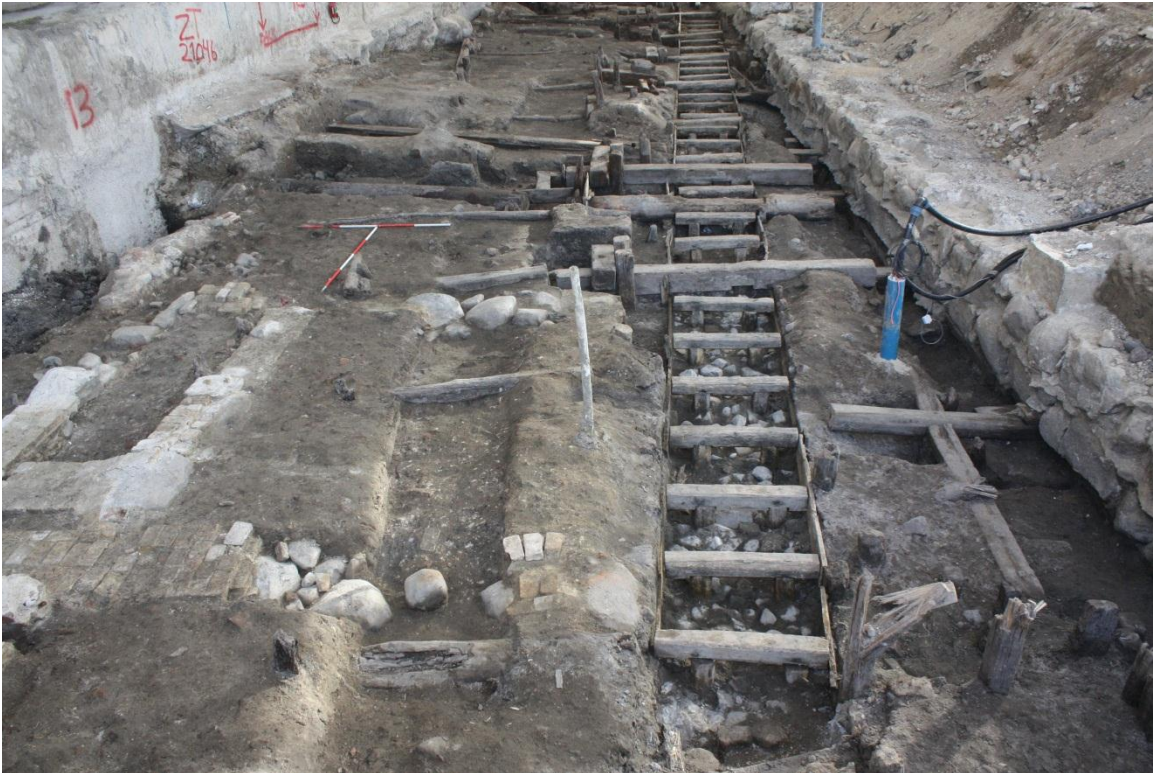
Fig. 203 Remains of the mid 19th Century linear Fiskegang (in centre of photo) after the 1860s concrete base has been removed. This was replaced in the 1880s by the harbour wall to the right of the photo.
